**NOTICE OF A JOINT WORK SESSION OF THE TOWN COUNCIL  
AND HISTORIC PRESERVATION COMMISSION  
OF THE TOWN OF CLARKDALE  
WEDNESDAY, OCTOBER 25, 2023 AT 6:00 PM**

## CLARKDALE BAND STAND *STRUCTURAL EVALUATION*

**Subject:        Band Stand - Structural Evaluation**  
**Clarkdale, AZ 85324**

## ***MUNICIPAL BUILDING ASSESSMENT*** CLARKDALE, ARIZONA

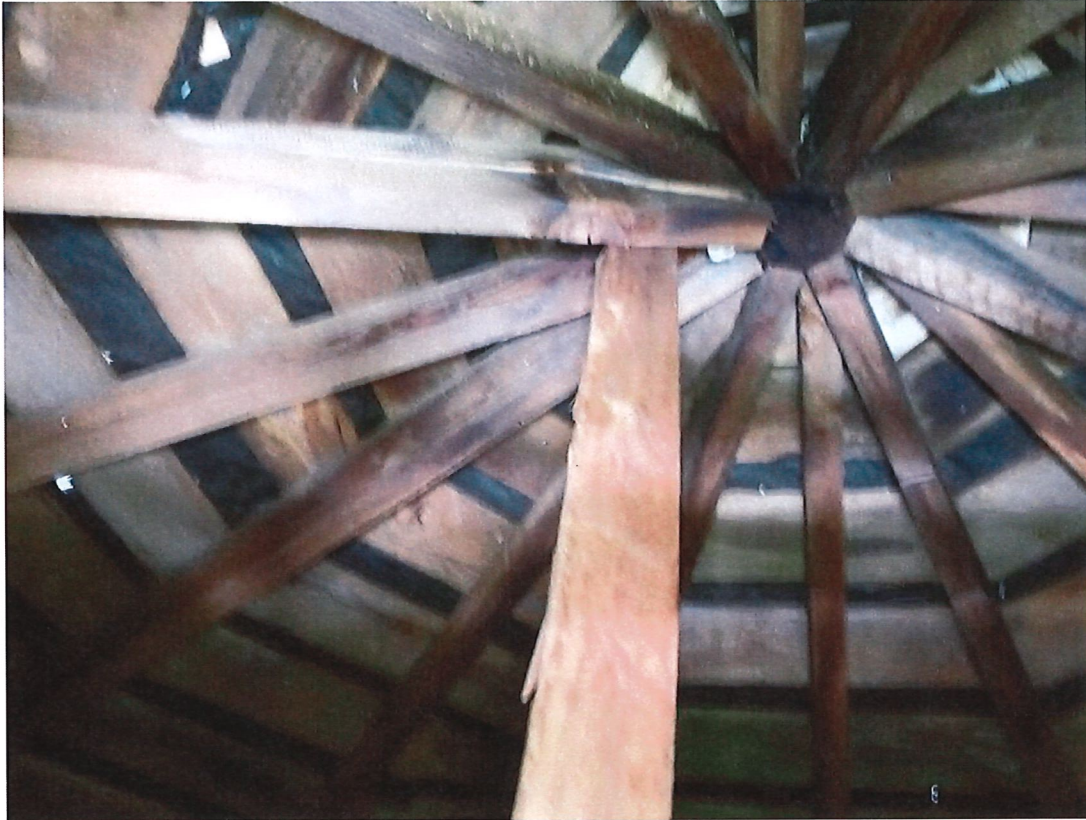
are cut at an angle and nailed to the side of the larger joists. Two approximately 2x6 posts (one of relatively newer age based on its blonde appearance) are screwed to the side of a roof joist and a ceiling joist (see photo 2, 3 and 4). Two screws are at each end. It is not apparent if either post is a brace to either of the individual joists it is attached to or an additional level of support for either the roof or ceiling as a whole. We observed that one of the roof joists is split.

Photo 2 – Center of Underside of Roof

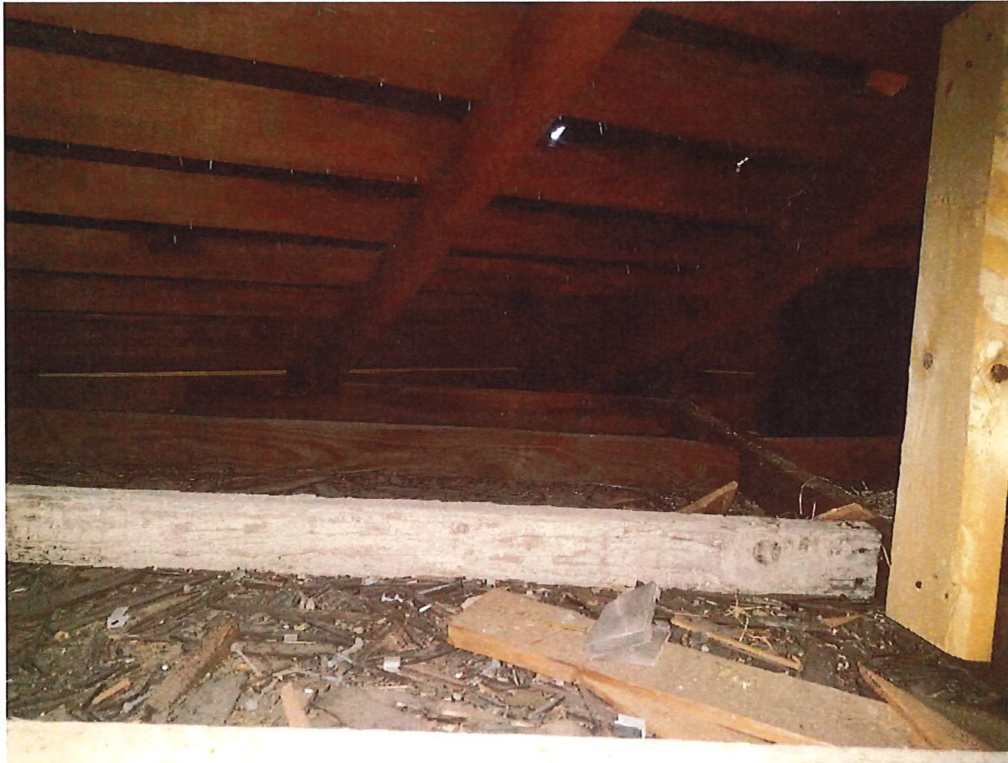
- *Ceiling Structure:* Spanning between the rim joists are dimensional 2x4's to support the 3" lath with a slight rounding used for the ceiling. A central beam runs corner to corner of the octagon and supports the 2x4 joists running (generally) perpendicular between it and the rim joists. (Photos 3, 4, and 5)

- *Ceiling:* The ceiling is made of thin 3" strips of rounded wood lath. There is a significant amount of wood debris on the ceiling that appears to be from the shingles as well as some trash. (See photos 3, 4 and 5). The debris obscures much of the top of the ceiling from sight and the condition of the ceiling wood is mostly indiscernible. The visible wood is covered in dirt. From below, the ceiling is painted white and the connection method is not visible though it is likely simply nailed to the ceiling joists. (see photos 6 and 7) The ceiling has a small hatch access hole offset from the center.

Photo 3 – Ceiling rafters and roof structure

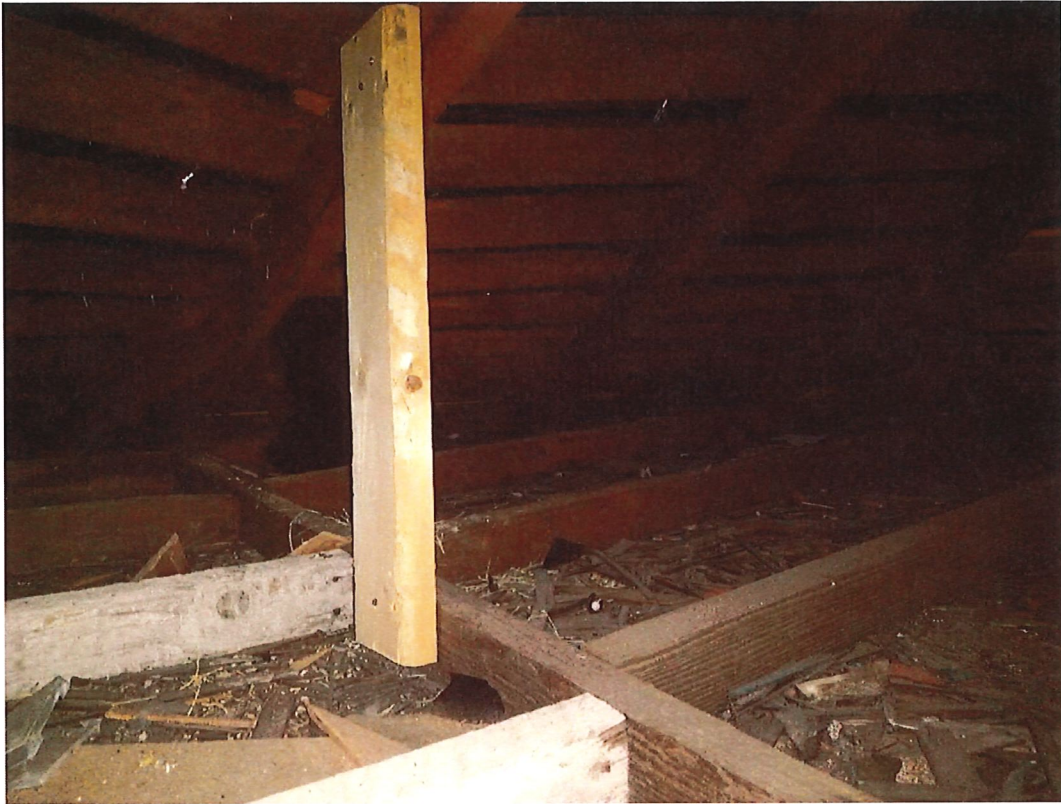
Photo 4 – post in ceiling

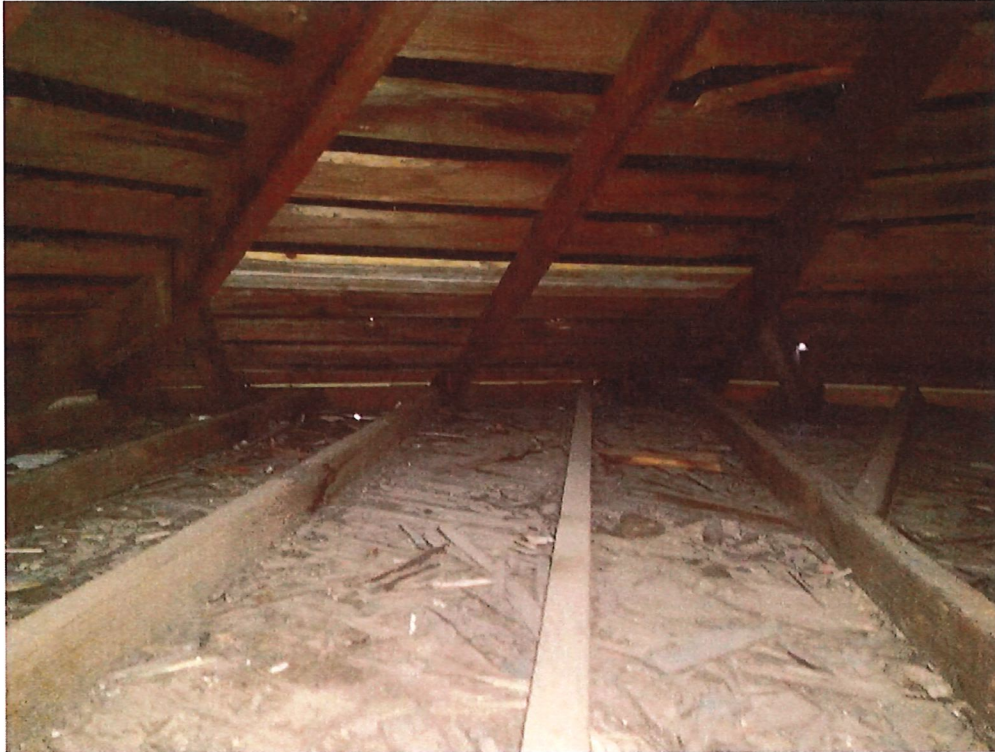
Photo 5 – Ceiling rafters and roof structure

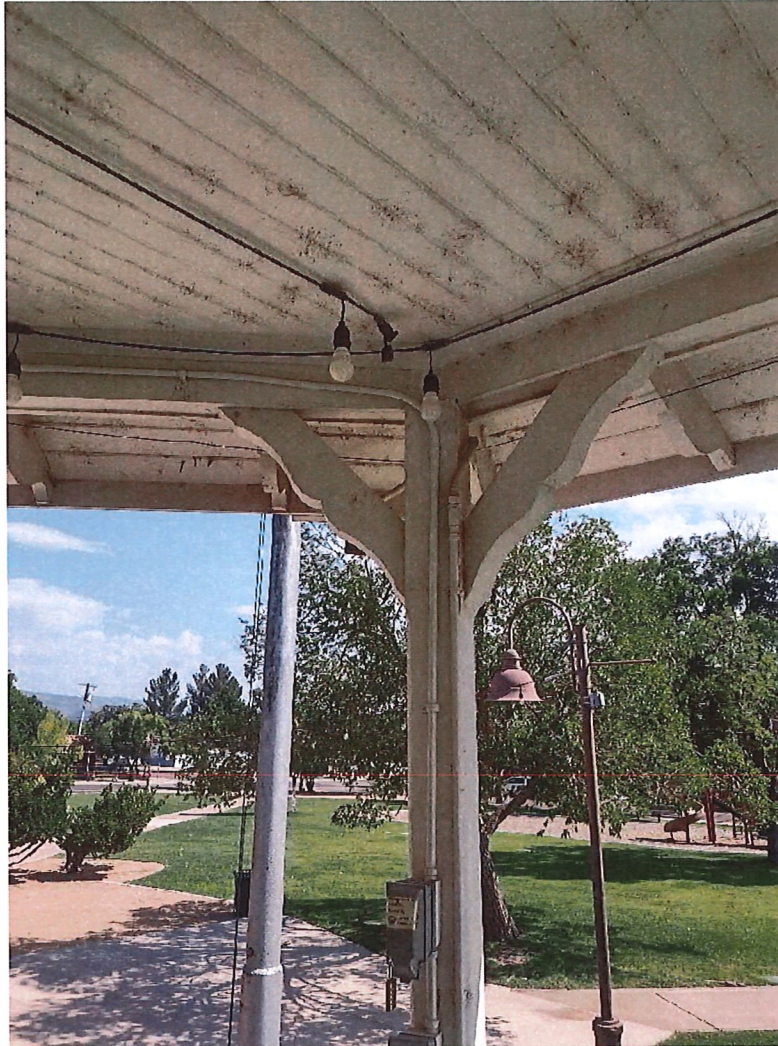
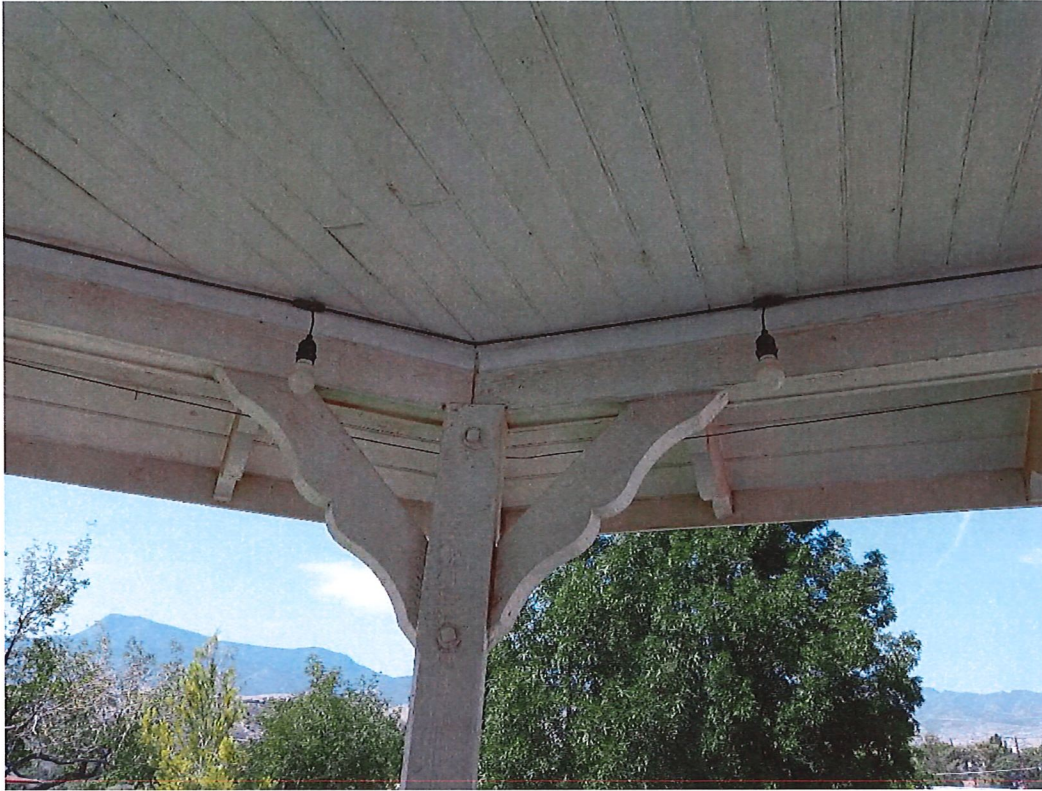
Photo 6 – View of Ceiling Lath and Column with knee bracing

Photo 7 – View of Ceiling Lath and Column with knee bracing

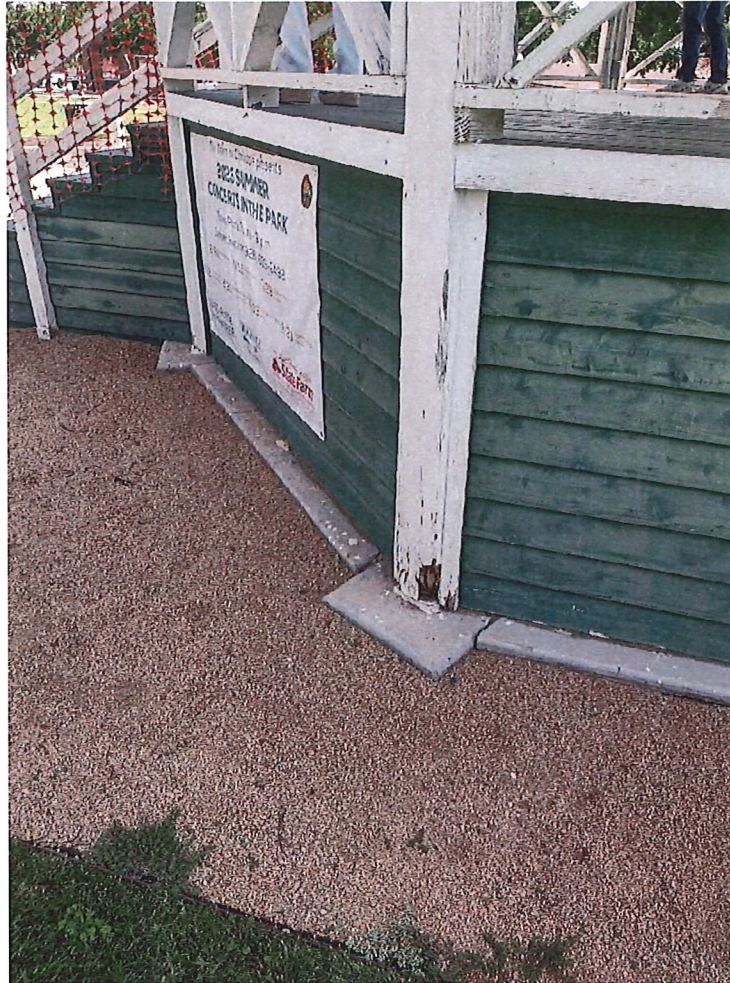
- *Columns:* The eight 6x6 wood columns are the most visible outline of the structure. Each has damage, primarily from wood rot and disintegration at the base, some more extensively than others (see photos 8). Each of the columns, whether above the floor line or below, shows some degree of being out of plumb. Heavily painted, it is not discernable by cracks or other stress indicators if the alignment is due to shifts in the structure or ground support or is from the wood drying and twisting or is the alignment of the wood when originally placed in the structure.

- *Exterior Walls/Siding:* On both sides of the staircase and below the floor around the rest of the octagon, the area under deck is walled in with lap siding appearing to be made of 1x material. It is supported with a frame of 2x4's resting on the concrete slab and nailed to the adjoining columns and floor framing. (see photo 8)
- *Concrete Support System:* A concrete slab is visible under the octagon and extending outside the octagon approximately four inches. The columns appear to rest on separately poured piers approximately 18" square. No subsurface exploration was done and no subsurface dimensions are known. The top of the slab and piers is essentially ground level. A decomposed granite ground cover provides separation between the band stand and the park lawn and on some sides there is an inch or two difference between the ground surface and the concrete surface. (see photo 8)

Photo 8 – Poor condition at base of column

- Replacement of all columns. Each has some degree of displacement in its alignment vertically. Individual replacement could be accomplished by removing and replacing the column while bracing and blocking the rest of the structure in place. The insertion of new columns would likely entail significant customization of all of the effected connections to each column.

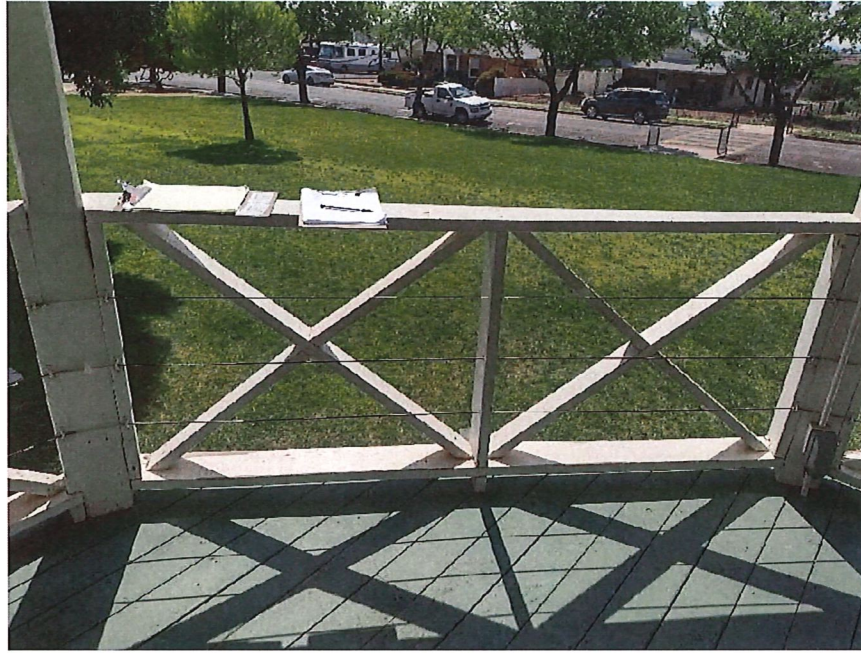
**Railings:** The railings are required to support a 500 lbs load applied laterally. The 2x6 rails bending stress for such a load is minimal, however, the shear load of 250 lbs at each end exceeds the capacity of nails whether in shear (138 lbs per nail) or pull out (40 lbs per nail) as the angle of each nail with respect to the load is uncertain and some reasonable percentage combination of the strengths would be applied as well as some amount discounted. These are considered to be unsafe.

Photo 9 – Railings

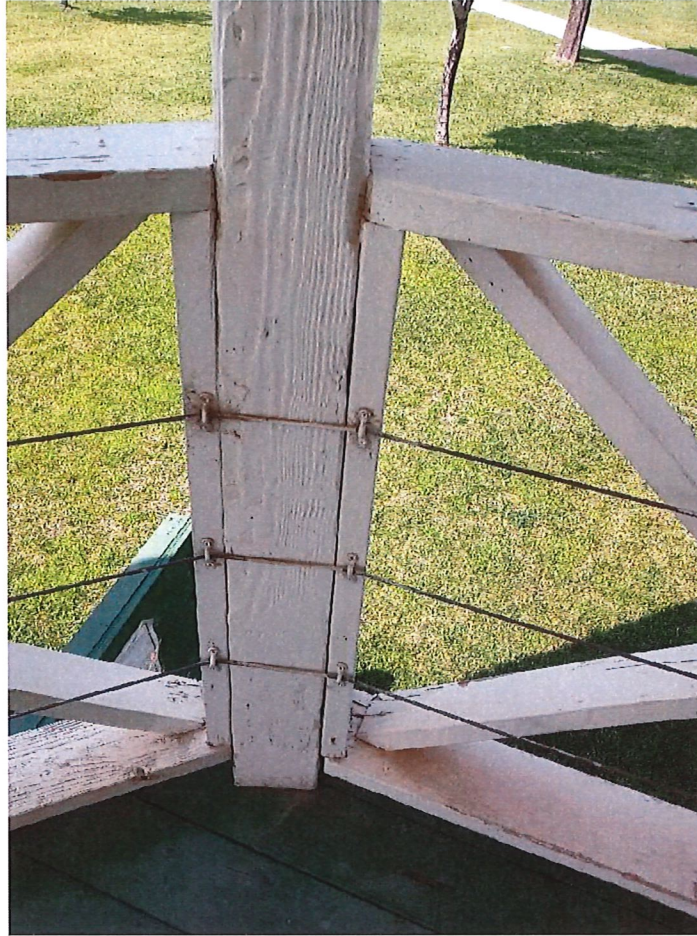
- *Railings:* With the exception of staircase location, each pair of columns has a handrail supported between them and above the floor. The rectangular frame and mid-vertical are of 2x6s and the diagonals within each box are 2x4s. All connections appear to be nailed. (See photo 9). Additionally 3 wound wire cables are attached to interior sides of the railings. (See photo 10).

Photo 10 – Railings at Column – Wires at Railings

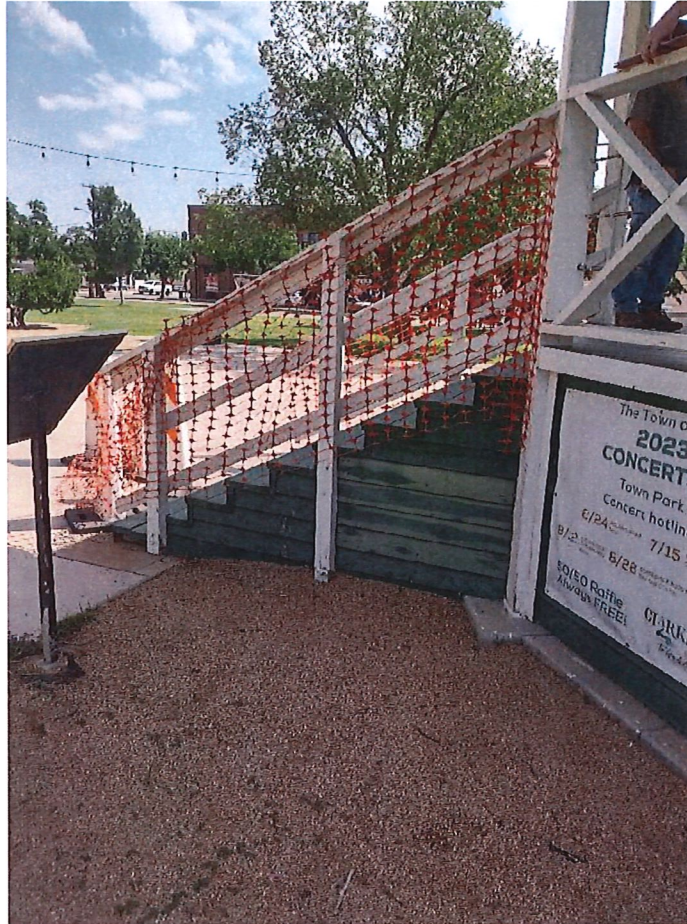
- *Stairs:* The staircase consists of nine (9) 11" steps with nine (9) 6" risers and one half size riser at the bottom. The steps span the opening between two columns and consist of the same 2x6 planks found on the octagon deck. The handrails span two 4x4 columns at the bottom and middle and connect to the 6x6 columns at the top. Three 2x6 planks, evenly spaced form the rails with a 2x6 placed flat on the top rail and columns. A 1 1/2" +/- tube rail is attached to the top wood rail on both sides. The bottom end of the staircase appears to rest on the adjoining Clarkdale Park central patio, separate from the concrete work supporting the band stand and spanning between. (See photo 11)

Photo 11 – Staircase

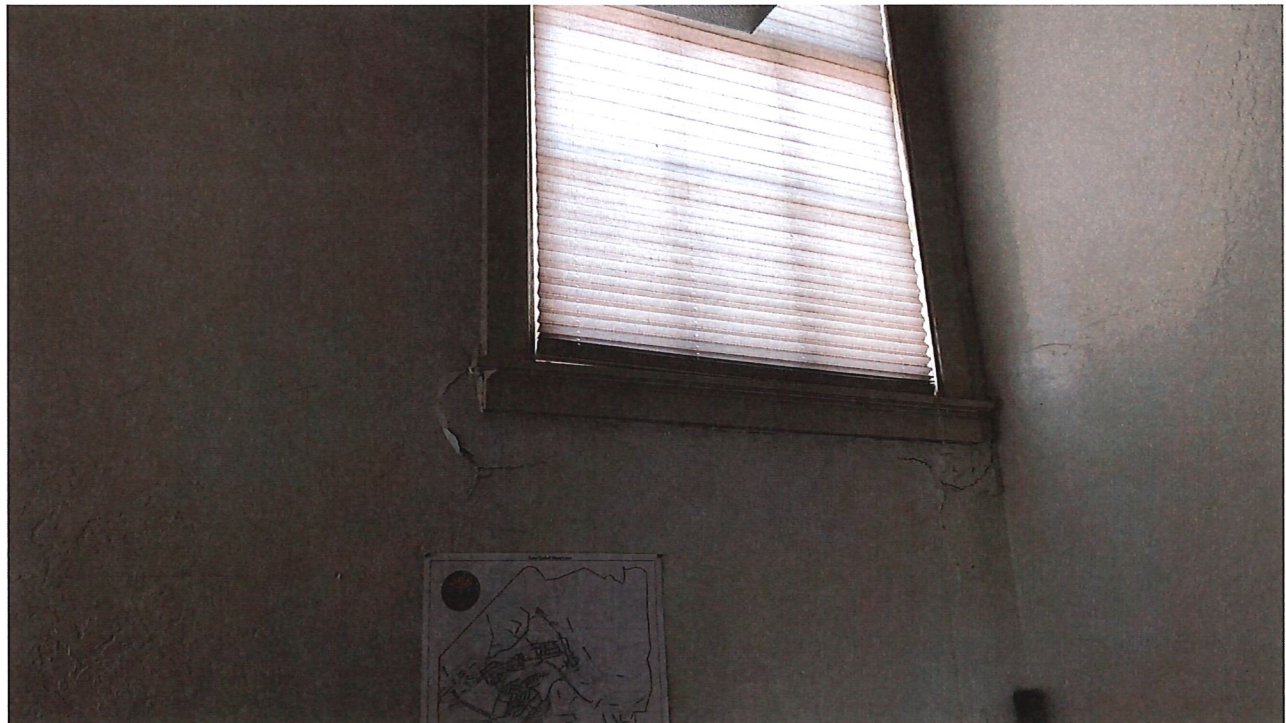
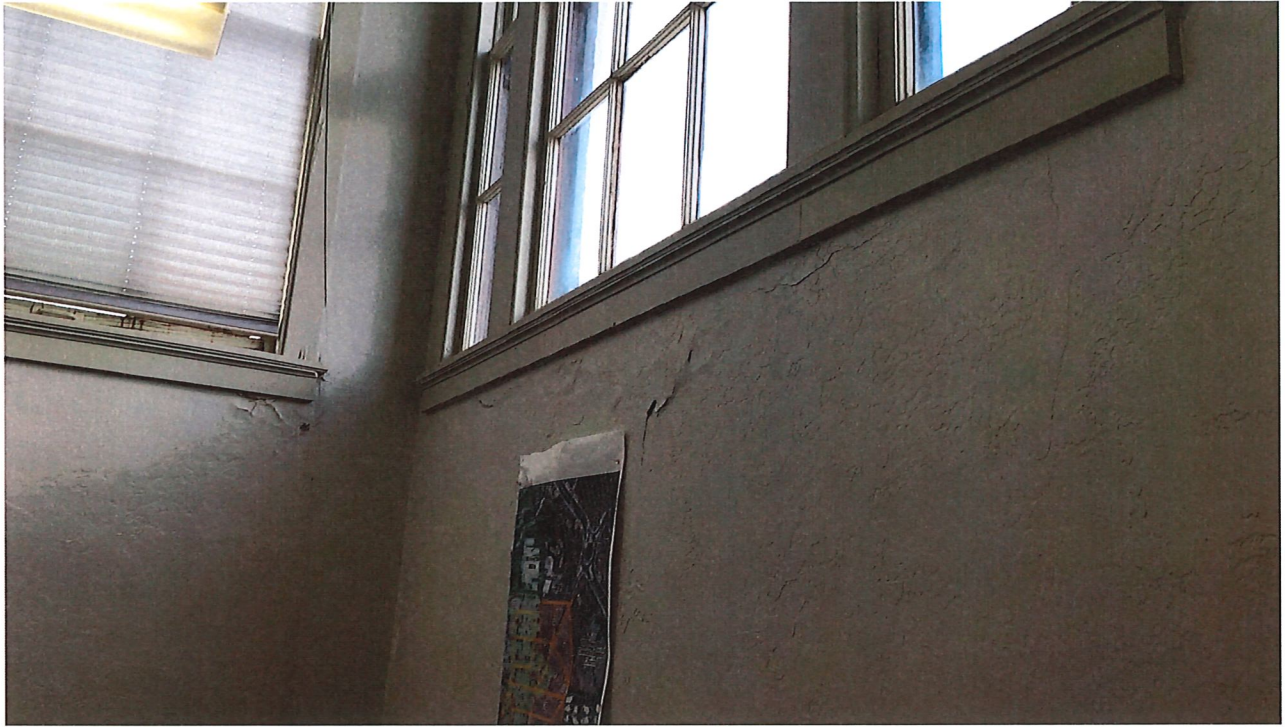
The Community Development and Public Works Building has interior plaster damage around the windows. This appears to be from water intrusion (Photo 2 and 3)

Photo 2: Window Damage - Public Works Building

Photo 3: Window Damage - Public Works Building

The exteriors of the windows and their frames should be scrapped, repaired, sealed, and repainted (if not replaced). The interior walls should have loose and broken plaster removed and the walls smoothed and painted. Any interior wall cracks at the windows or elsewhere should be reviewed for depth. If any of the cracks intrude into the mortar in the brick walls the mortar should be replaced and the bricks reset.

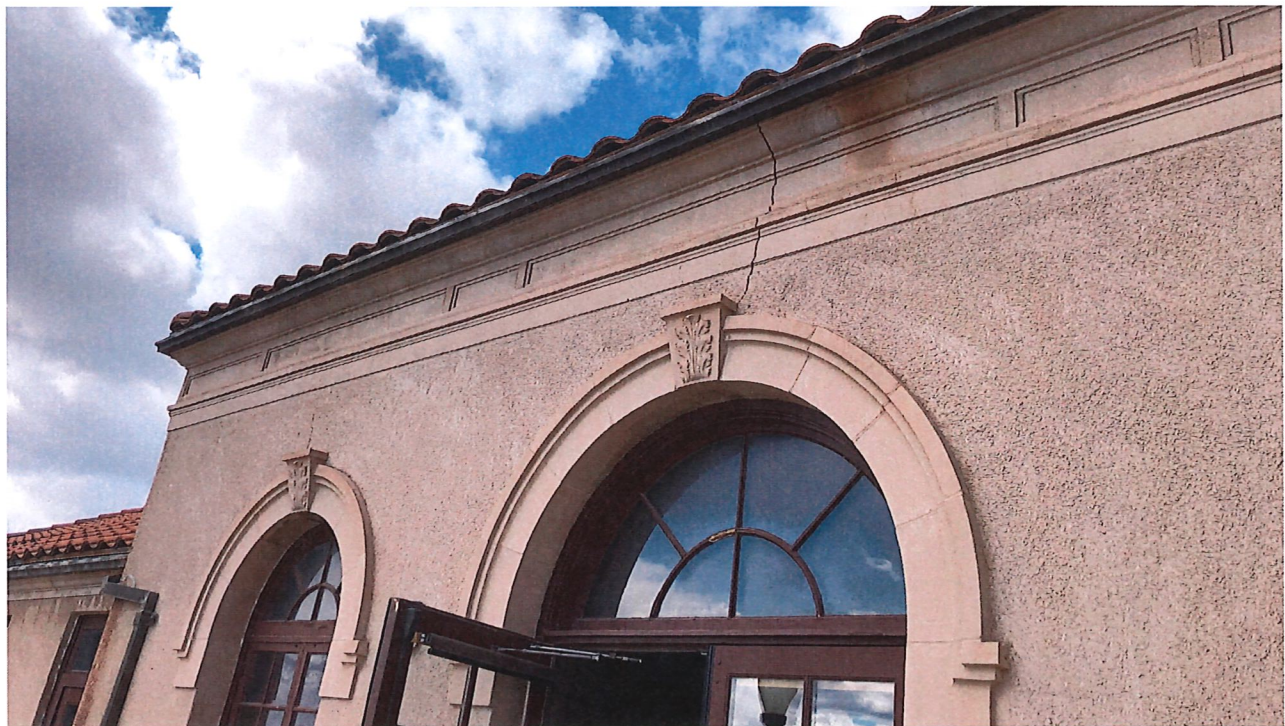
Photos such as #4 and #7 display cracks that need confirmation of the underlying construction material. The cracks do not appear to be generated by cracks through the wall and could be stucco only.

Photo 4 – Crack over Doorway of Clubhouse

Cracks in the walls need a flexible sealant to prevent water intrusion that could contribute to extending the separation of the stucco or lengthening the crack.

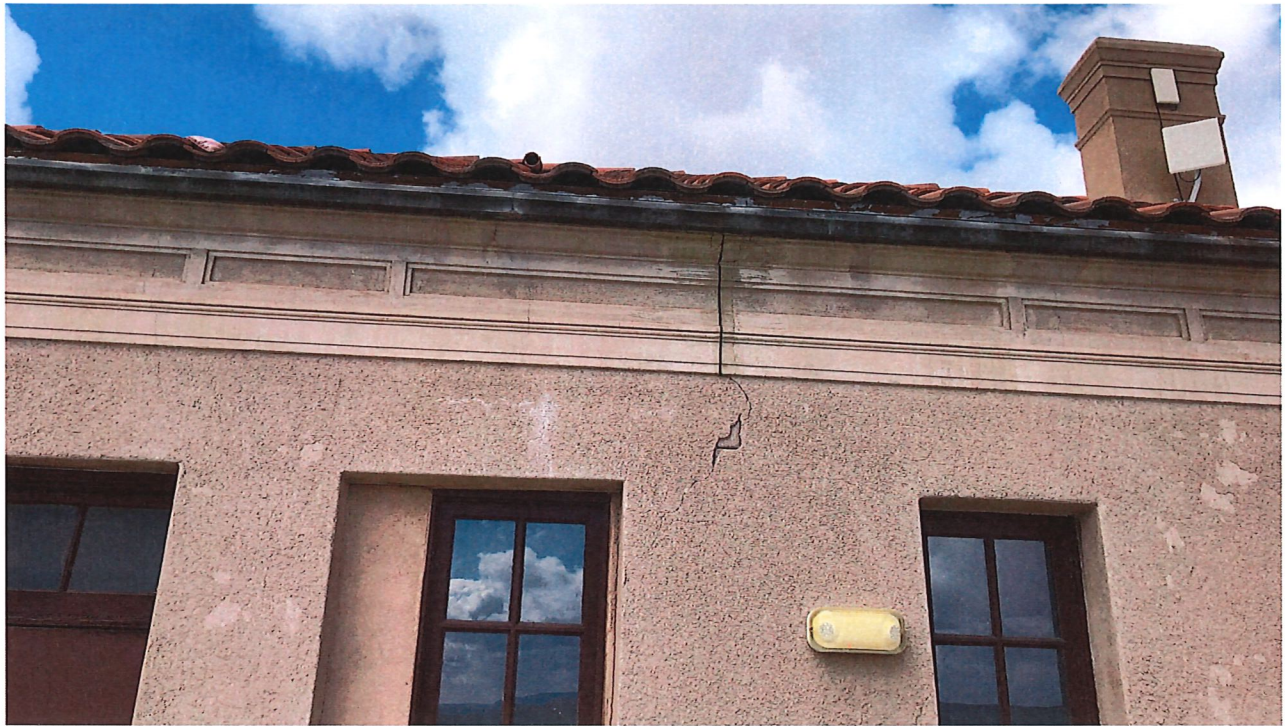
Cracks as seen in photos 5 and 6 confirm the underlying construction and indicate that the crack is likely in both the stucco and wall.

Photo 5 – Large Crack at soffit and below, Memorial Building

Replacement and repair to prevent water intrusion and other damages needs to occur. The vertical cracks at soffit joints need to be filled with sealant. The wall cracks need to be confirmed for depth when verifying the underlying material. Block and brick constructed walls with cracks extending into the wall will need to have the mortar removed and replaced. The repair and replacement of missing and damaged soffit could be extensive as such large cracks exist as to call into question its long-term stability.

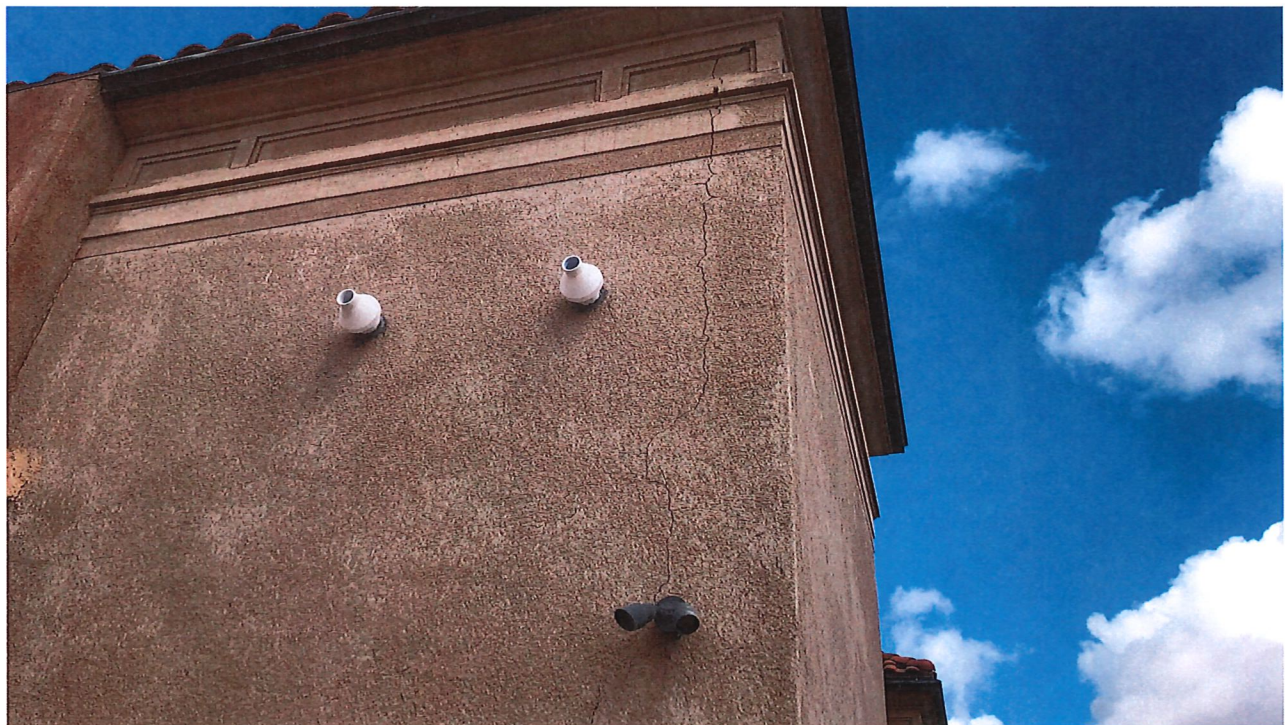
Photo 6 – Crack at Corner of Memorial Building (East Side)

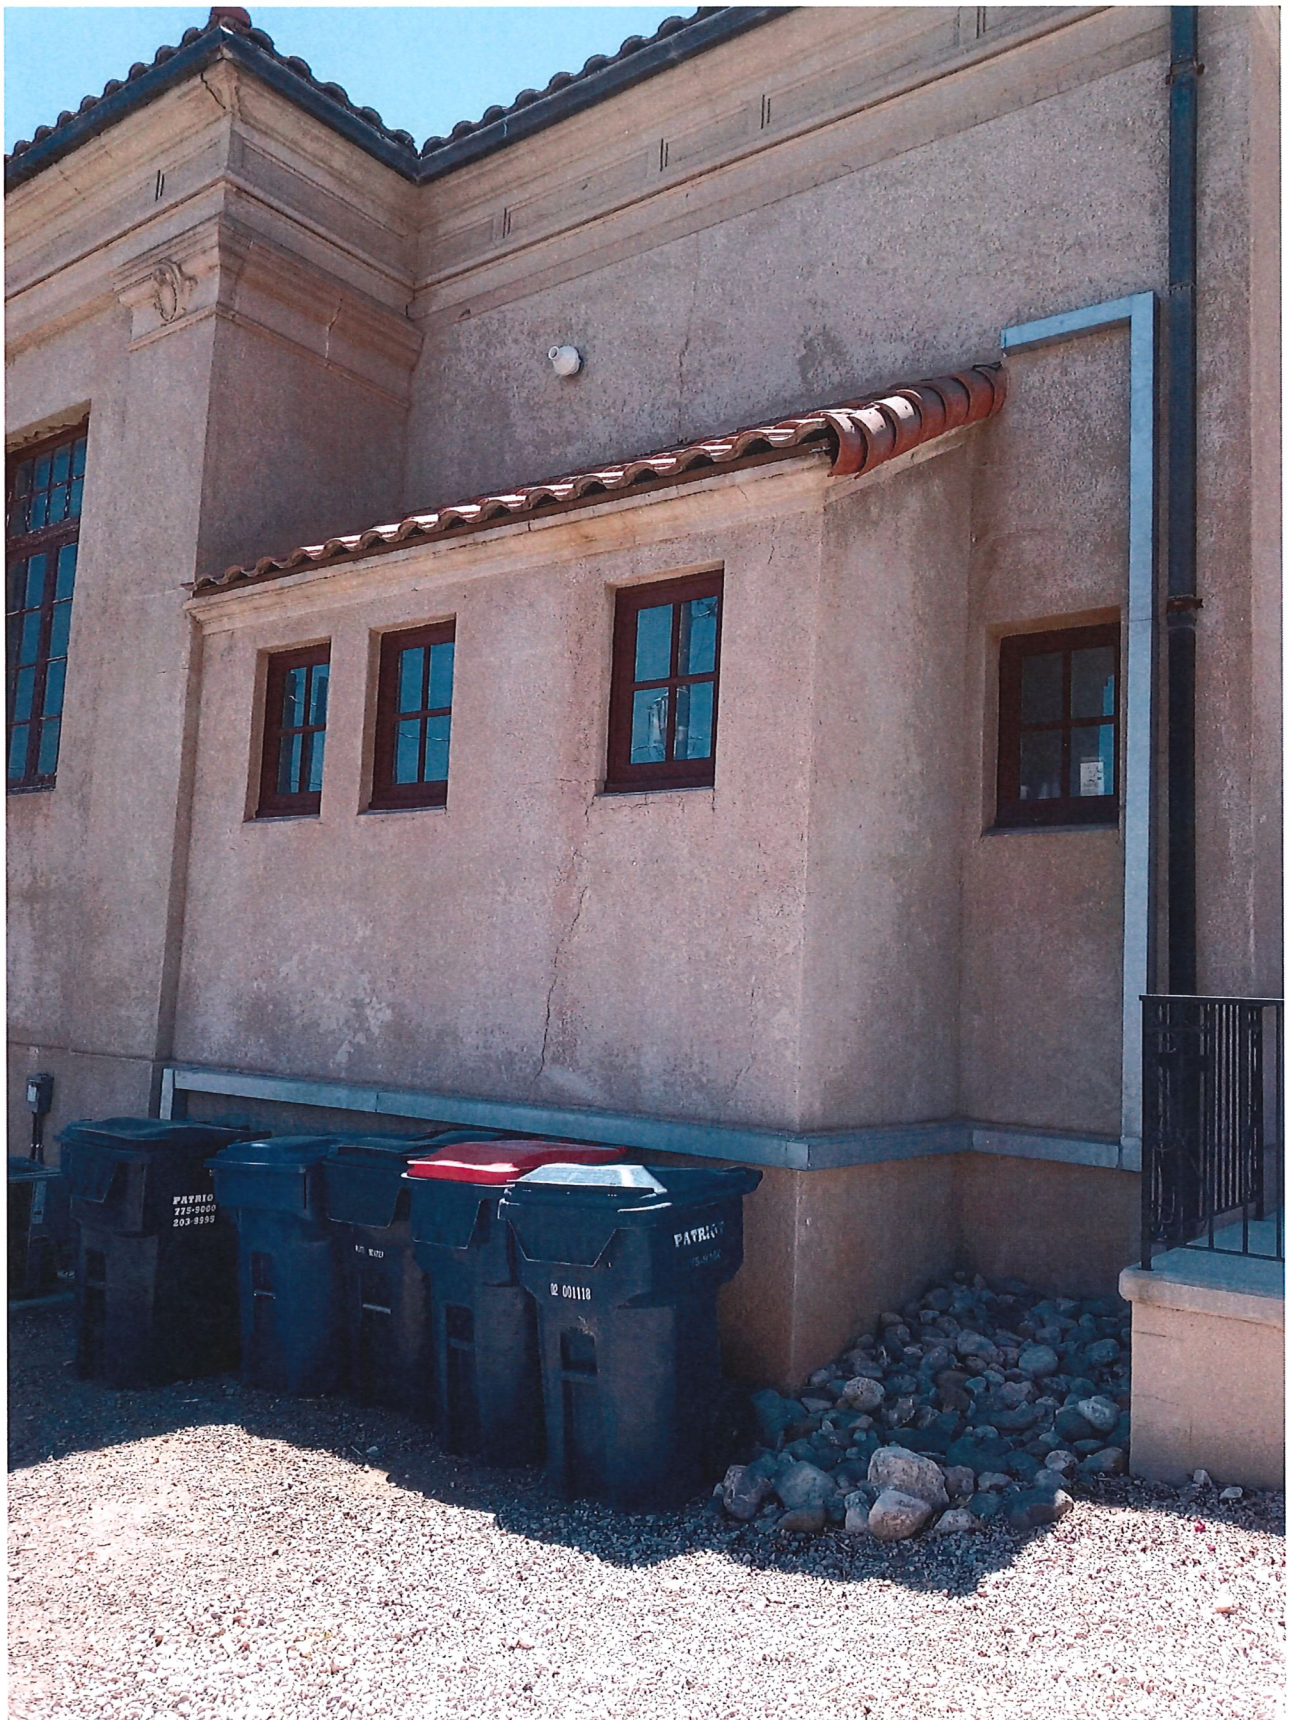
Photo 7 – Cracks in Wall, Memorial Building, North Side

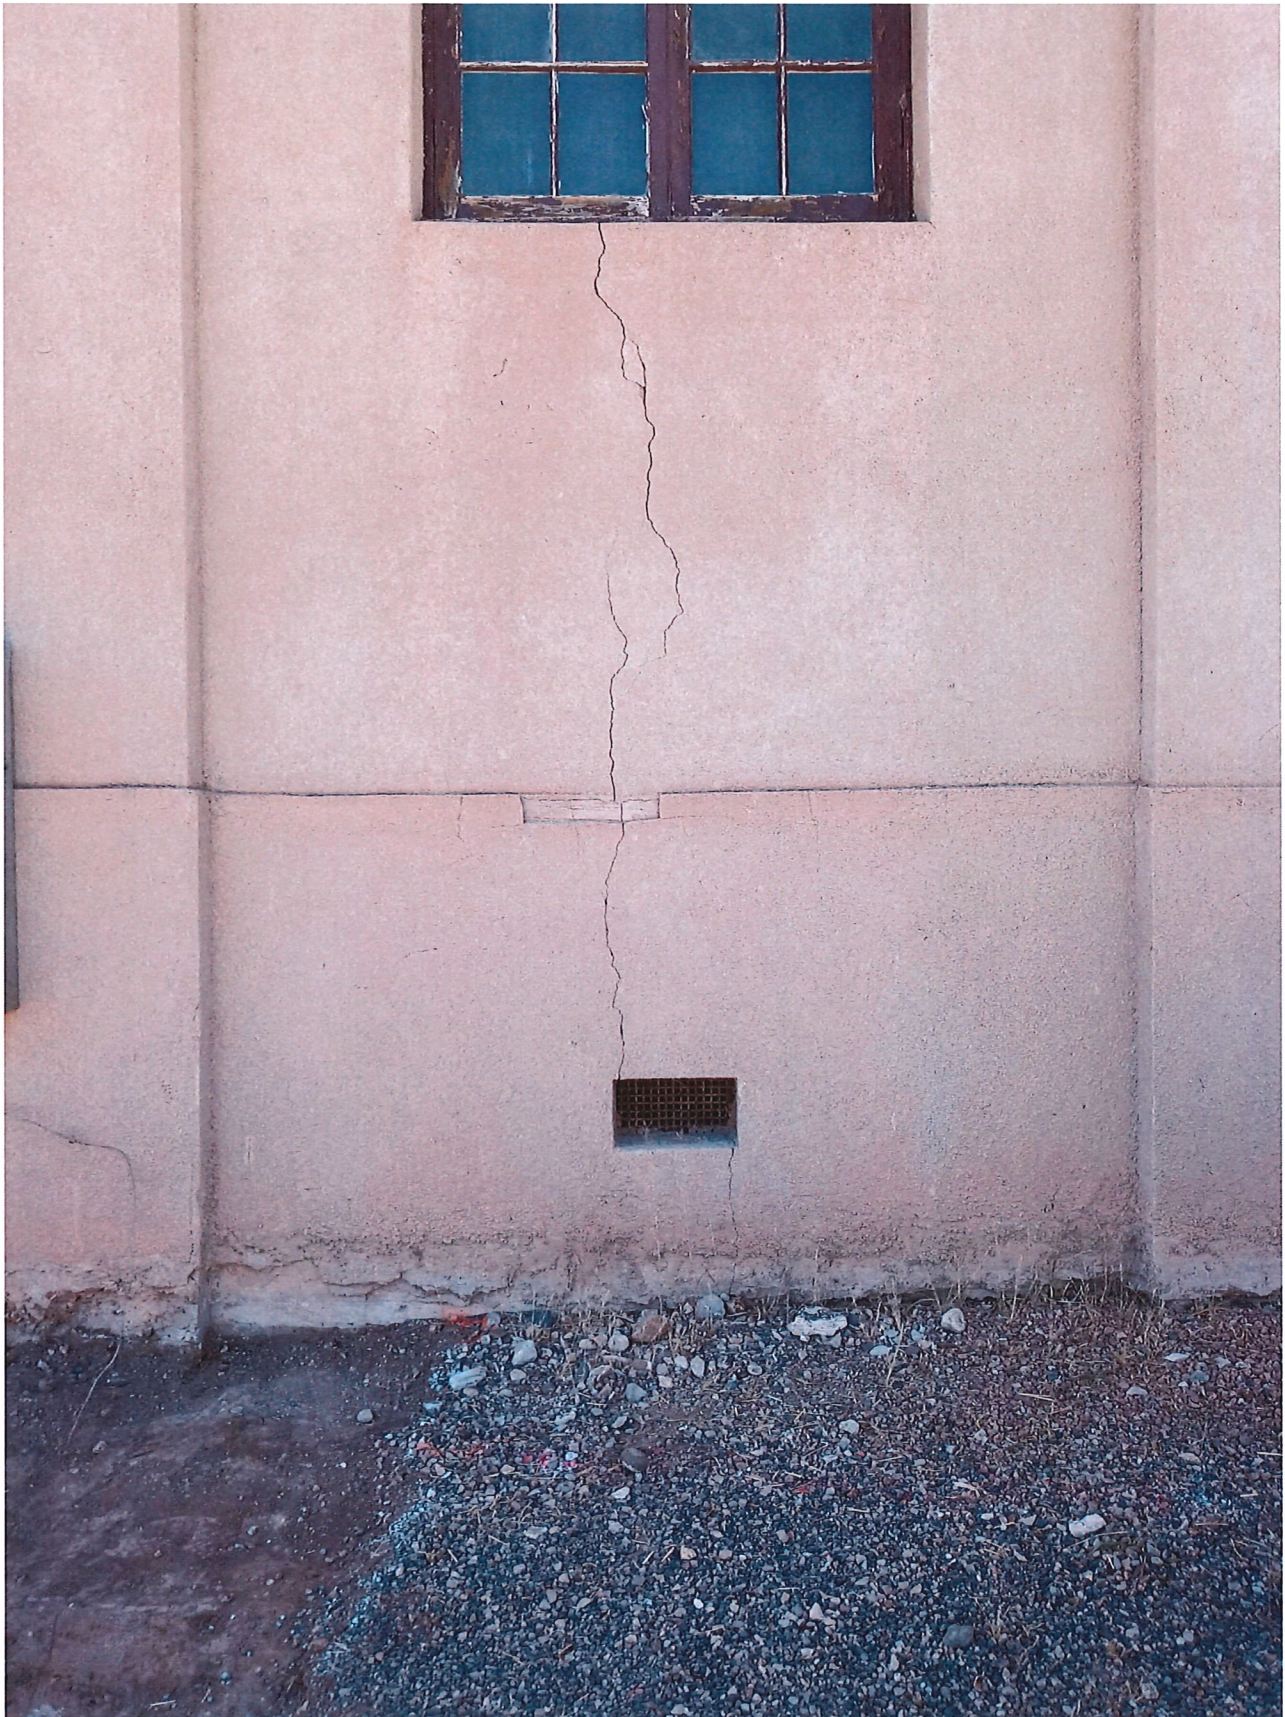
Photo 8 – Cracks in Wall

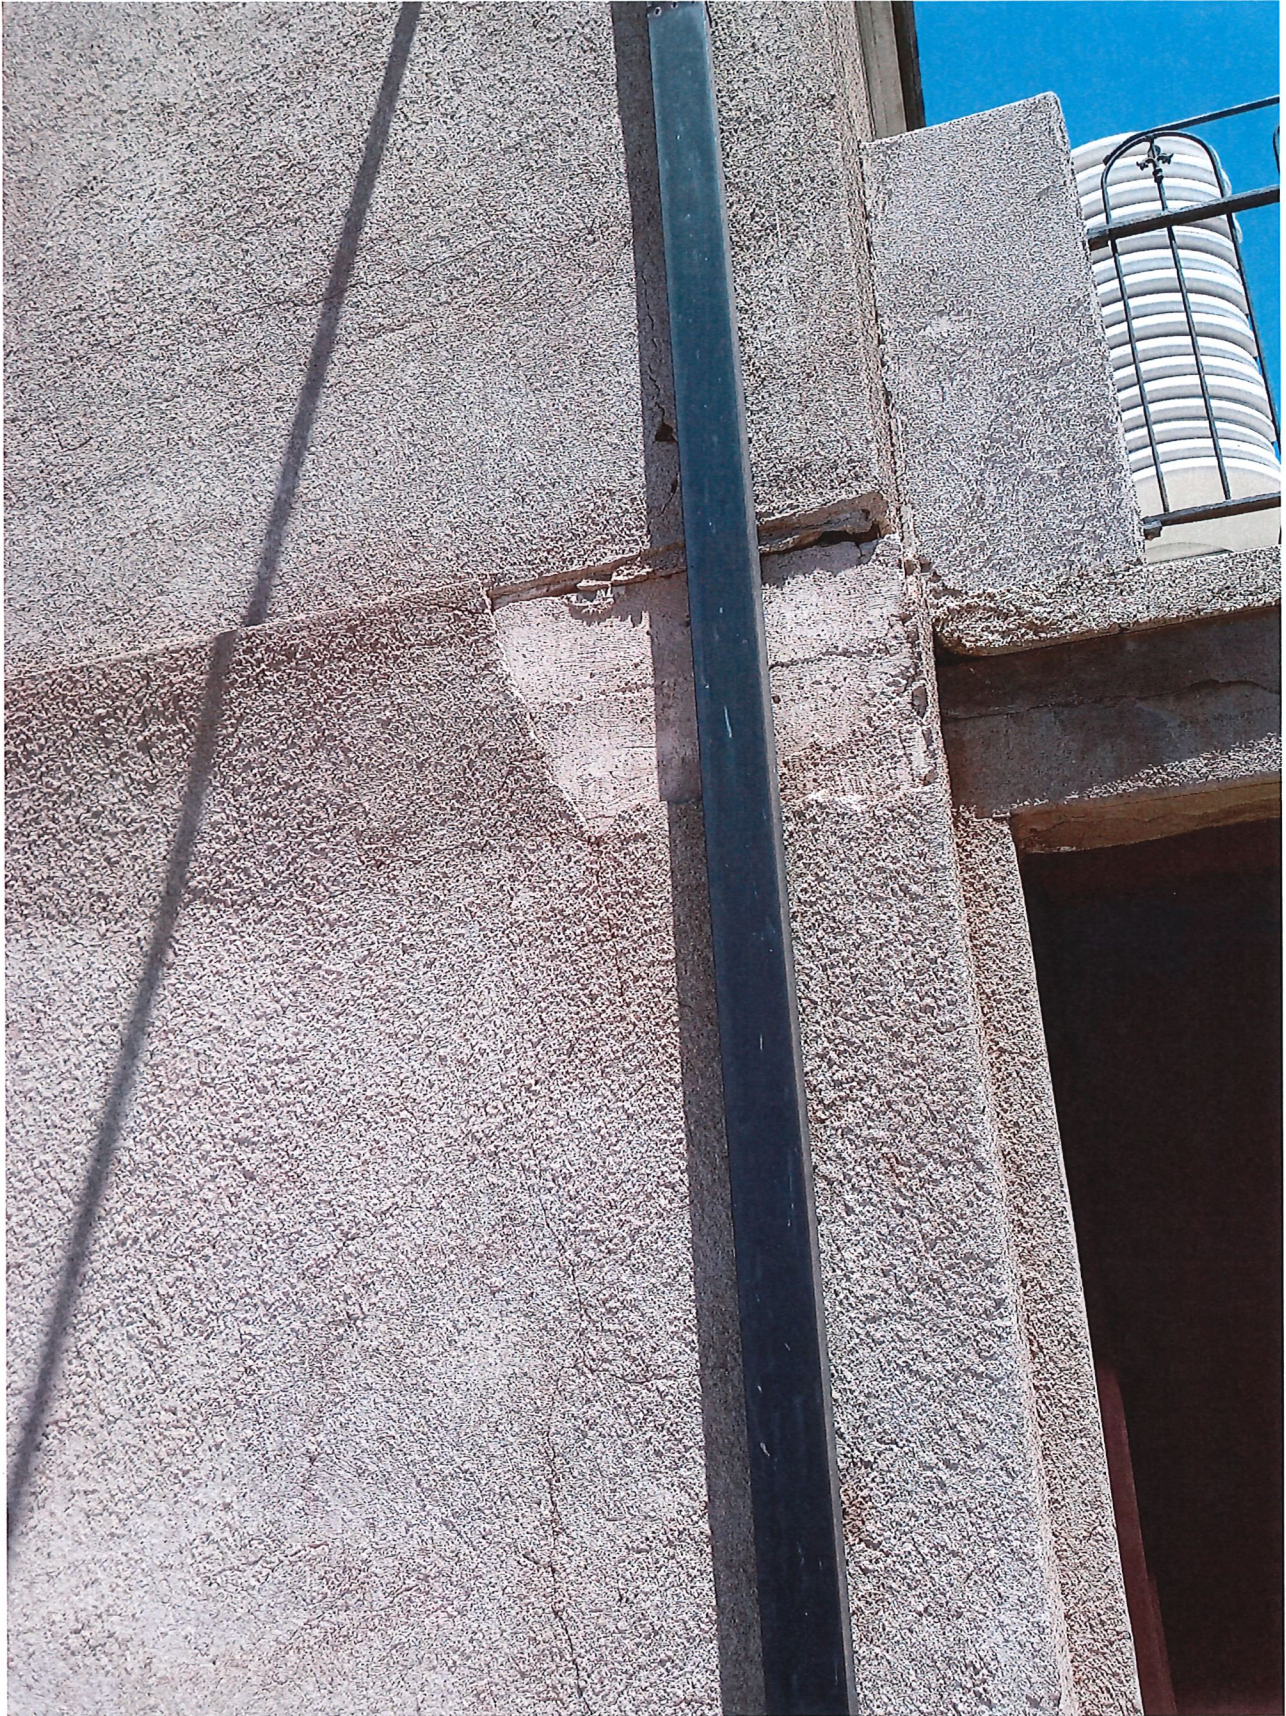
Photo 9 – Cracks at Doorway, Memorial Building, South Side

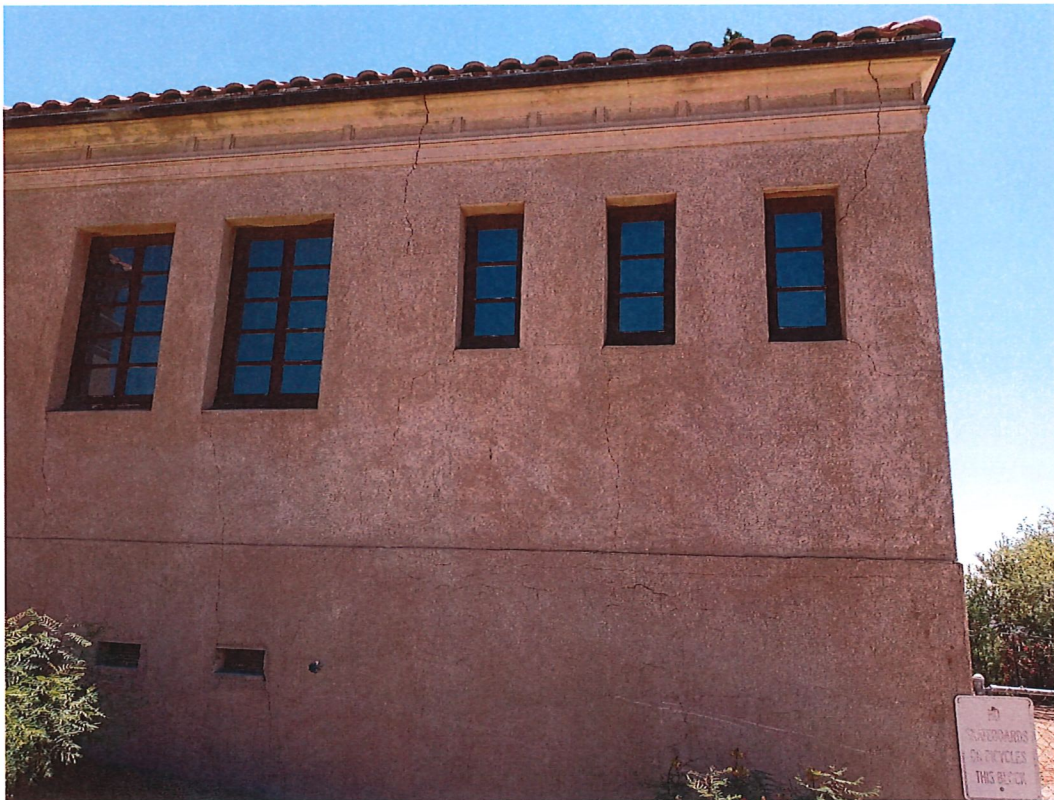
Photo 10 – Multiple Cracks in Wall, Memorial Building, South End, West Side
