**NOTICE OF A JOINT WORK SESSION OF THE TOWN COUNCIL  
AND HISTORIC PRESERVATION COMMISSION  
OF THE TOWN OF CLARKDALE  
WEDNESDAY, OCTOBER 25, 2023 AT 6:00 PM**

## CLARKDALE BAND STAND *STRUCTURAL EVALUATION*

**Subject:        Band Stand - Structural Evaluation**  
**Clarkdale, AZ 85324**

## ***MUNICIPAL BUILDING ASSESSMENT*** CLARKDALE, ARIZONA

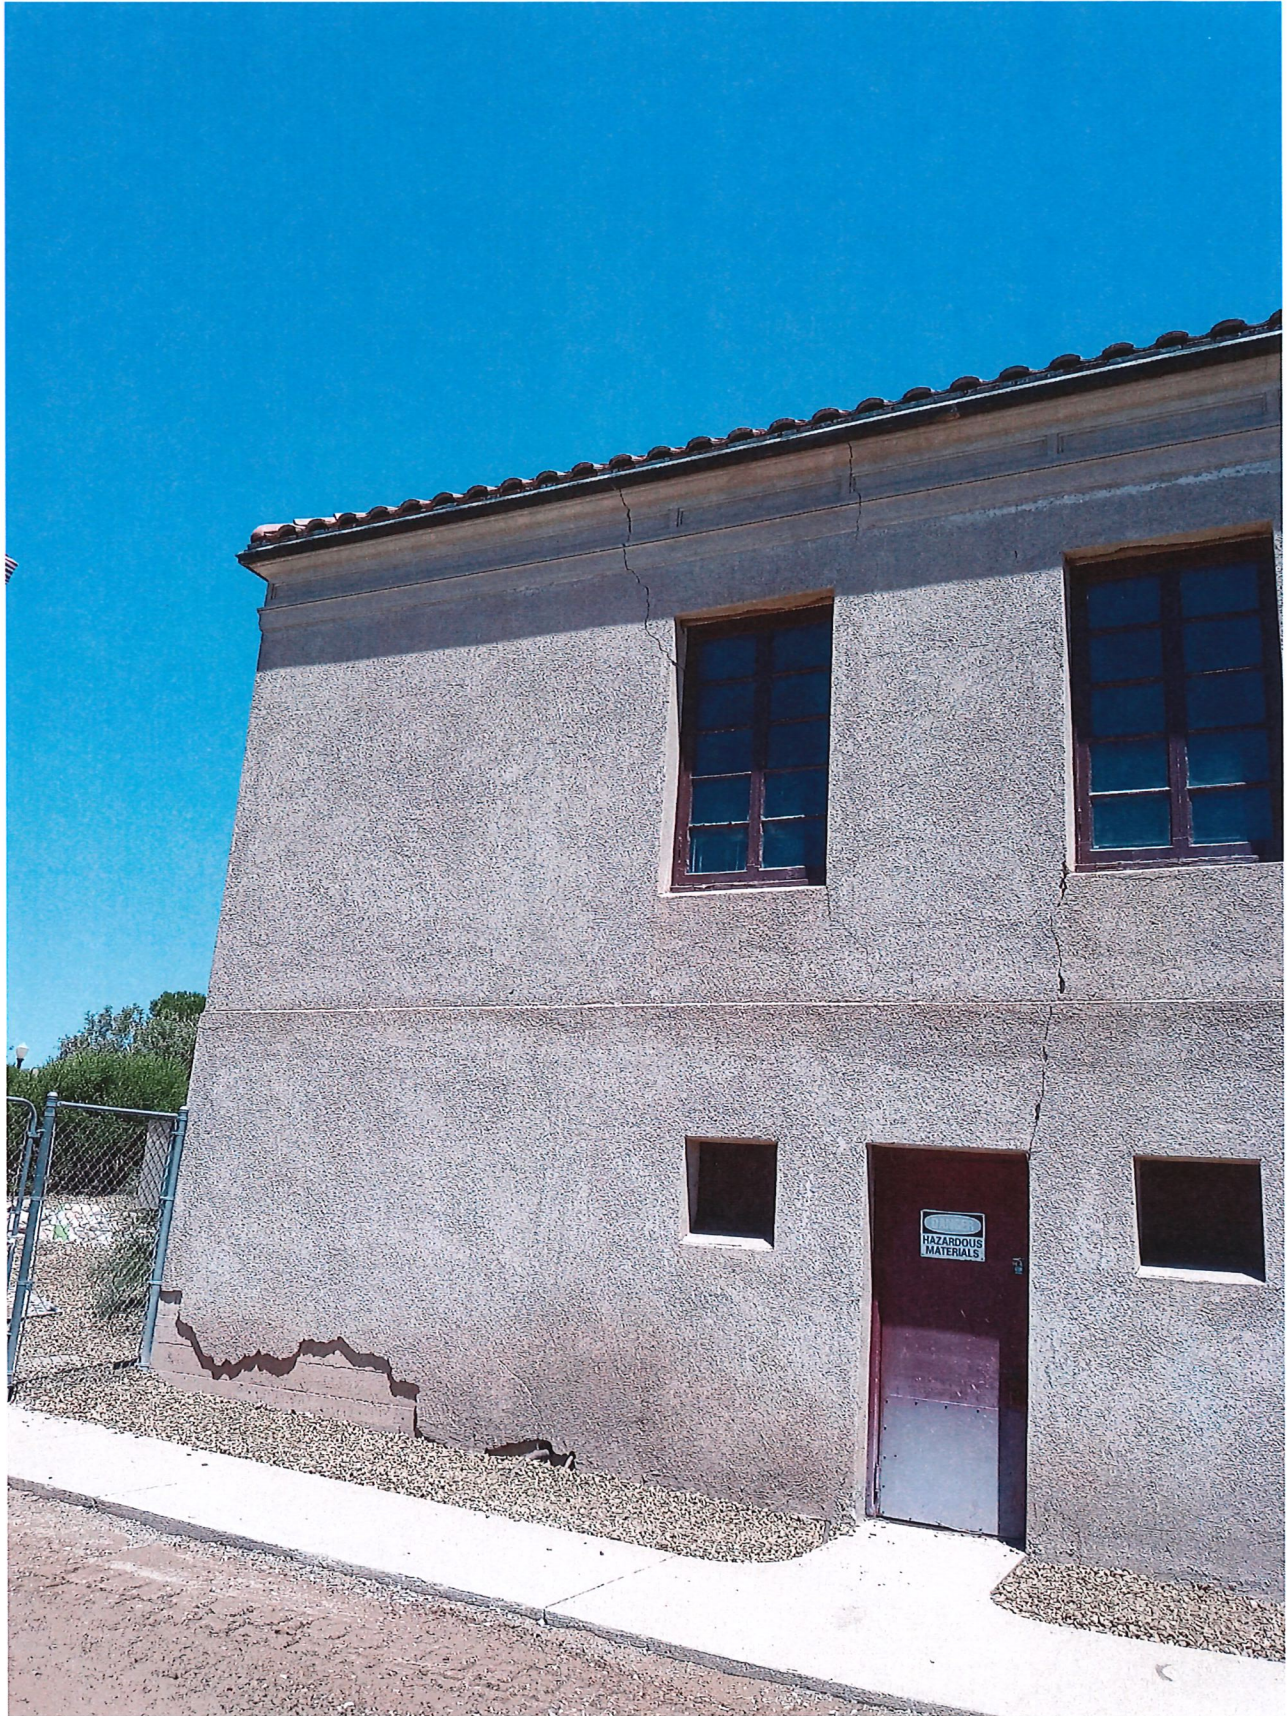
Photo 11 – Stucco Loss, Memorial Building, South Side

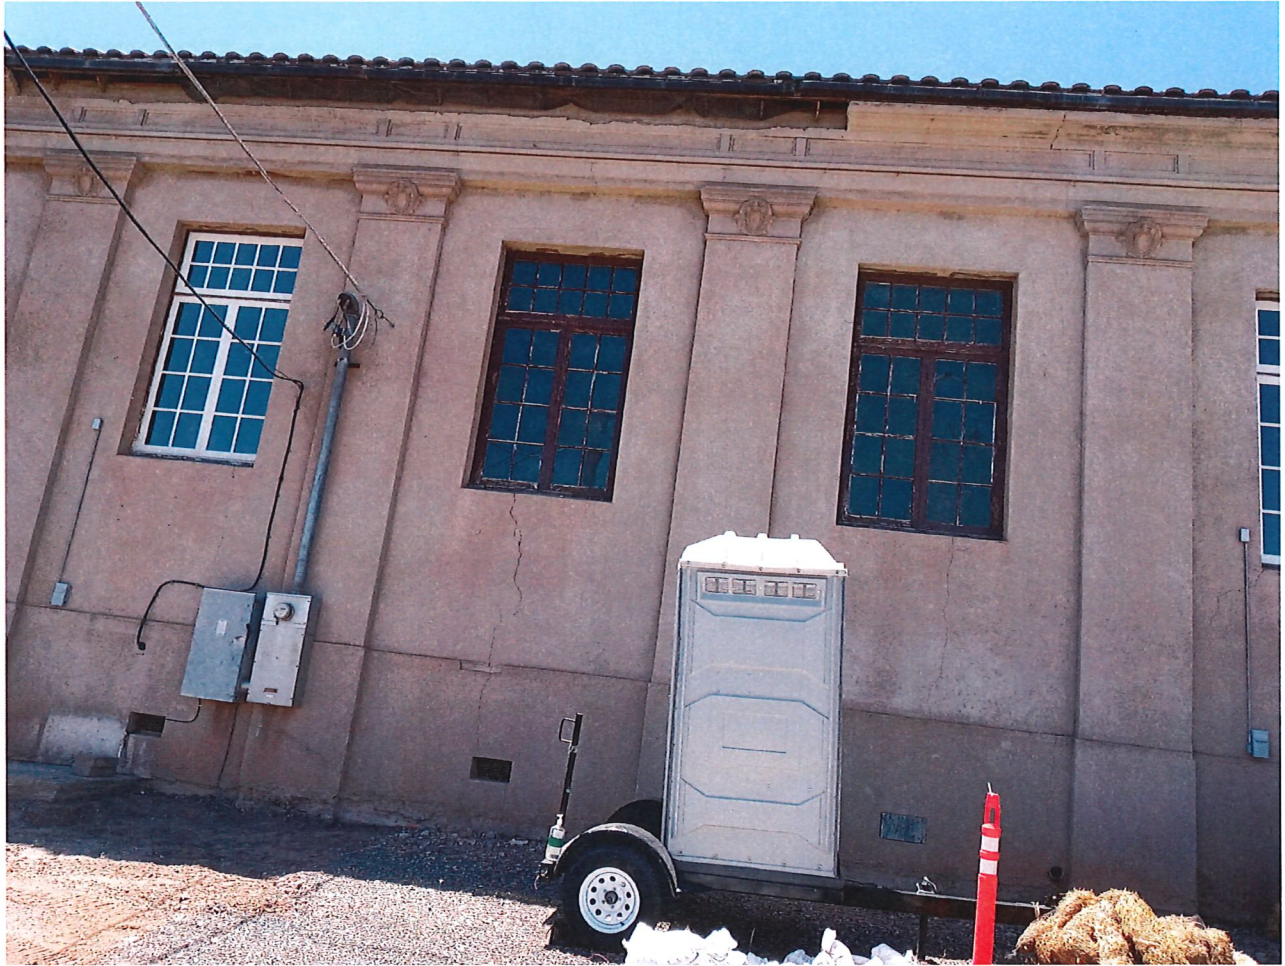
A large portion of the soffit of the Club House is missing in one area (north side – photo 12) and has a variety of sizes of cracks in other areas, some corresponding with cracks extending down the wall.

Photo 12 – Soffit missing - Memorial Building – North Side

C. Flashing, if used, usually leaves some portion exposed which may negatively altar the appearance and should be considered for appropriateness. Flashing is a "best practice". Any missing surfaces, such as soffits, are a priority for replacement.

2. The open soffits on the Clubhouse are also a higher priority. The cracks in the Clubhouse walls do not have interior damage identified as associated with them and thus have a lower priority than the work associated with the Public Works Building. The soffits of the Clubhouse are well above the ground and the attic space behind them may not have any accessibility but those locations require physically handling the

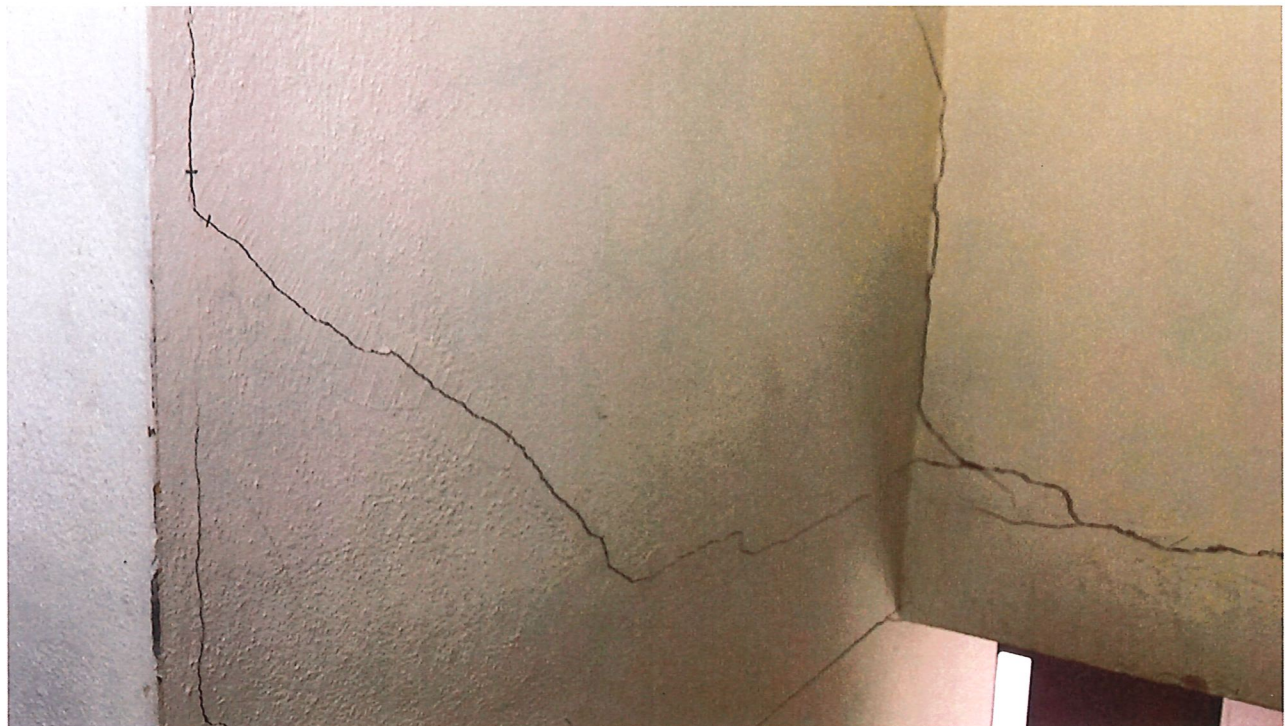
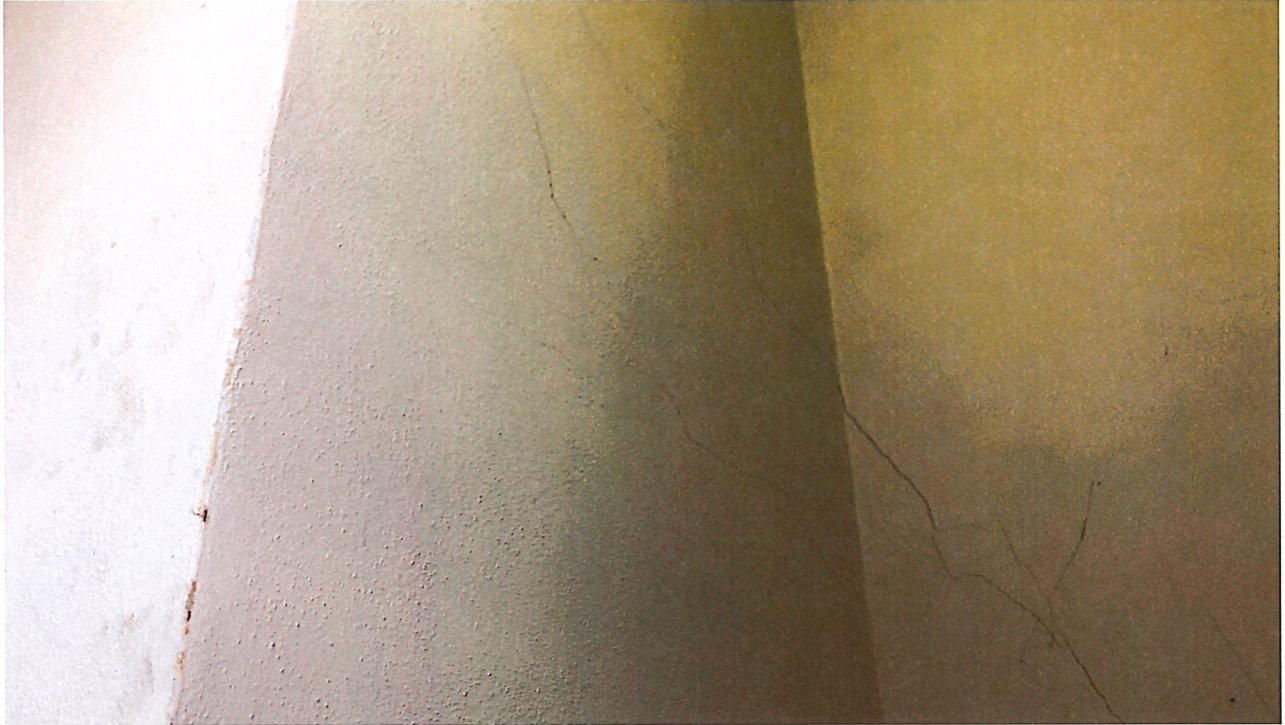
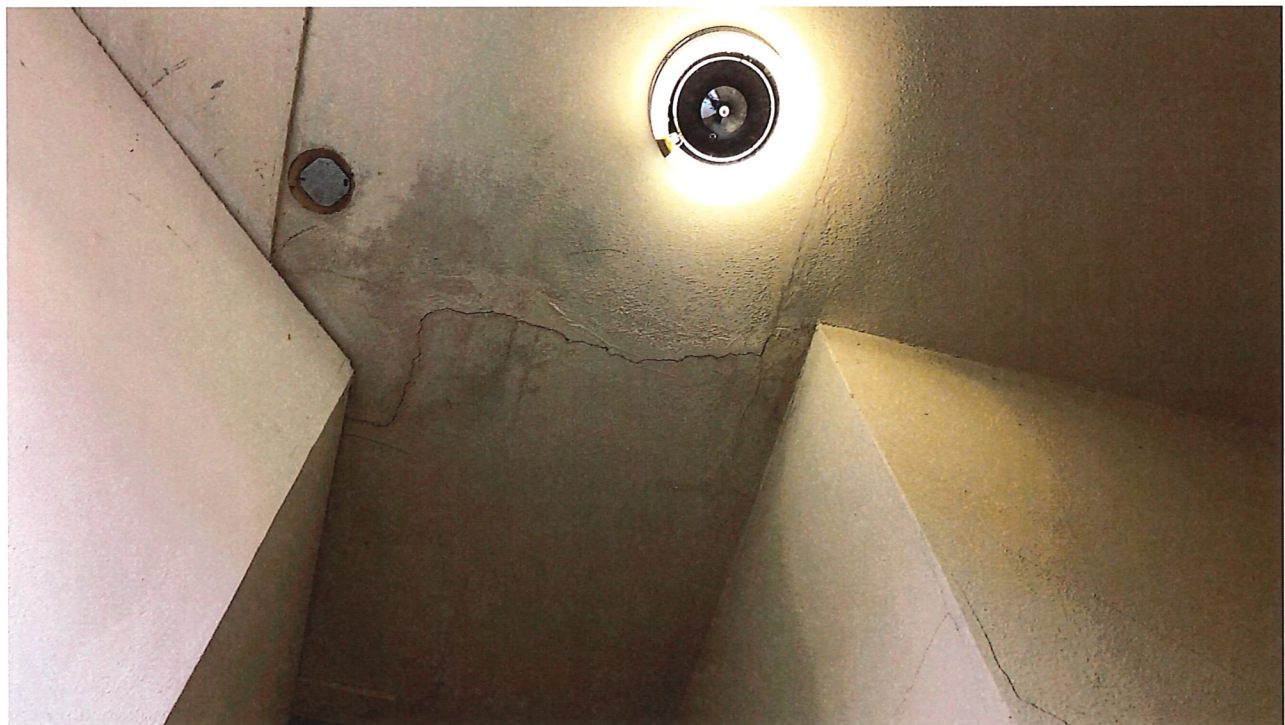
The stairwell at the rear of the library has extensive cracks in the wall around and the ceiling above (Photo 13-15). The exterior wall shows cracking that appears to confirm the crack extends into the wall (Photo 16).

Photo 13 – Wall Crack at Stairwell of Library

Photo 14 – Wall Crack at Stairwell of Library

Photo 15 – Ceiling Crack at Stairwell of Library

Removal of the drywall and/or plaster, examination for structural integrity or issues that allowed the wall movement, and repair by replacing the wall panels needs to occur.

3. The interior damage of the Municipal Building/Library staircase do not appear to be the result of weatherization issues and thus would be a lower priority.

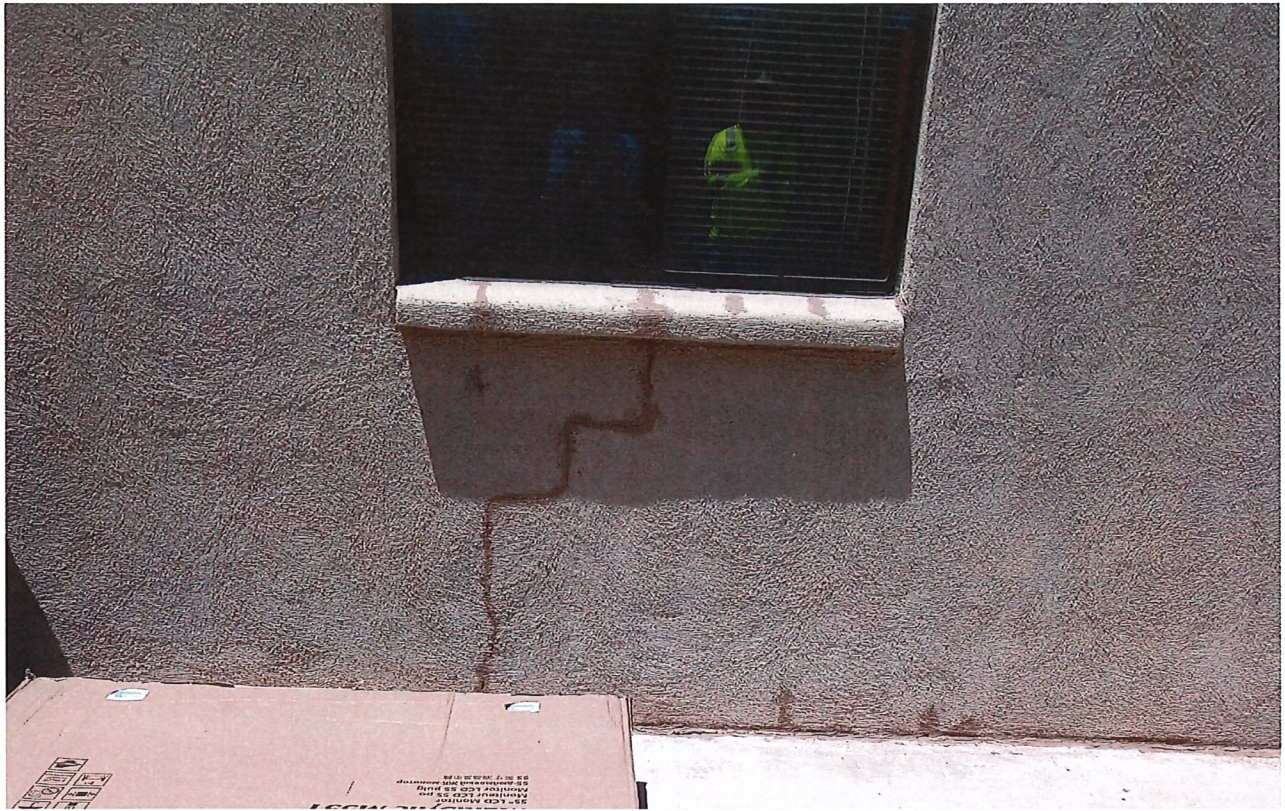
Photo 16 – Stairstep Cracks below window, Administration/Library Building

Some cracks are reflected from the wall materials and need repair through mortar removal and brick or CMU replacement.

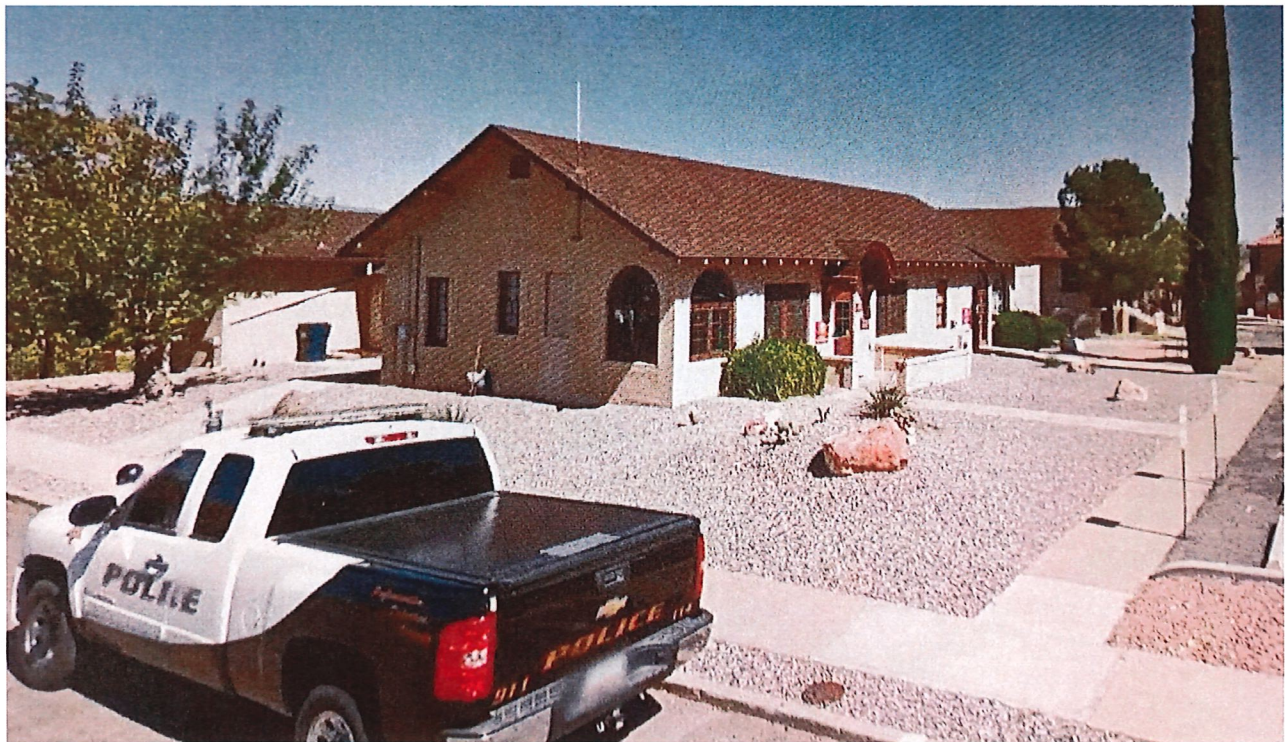
No deficiencies were observed at the Police Station (Photo 17).

Photo 17 – Police Dept. Building

No work is recommended at the Police Station
