Item Number: 4.A.

# CLARKDALE BAND STAND

## STRUCTURAL EVALUATION

**Subject:        Band Stand - Structural Evaluation**  
**Clarkdale, AZ 85324**

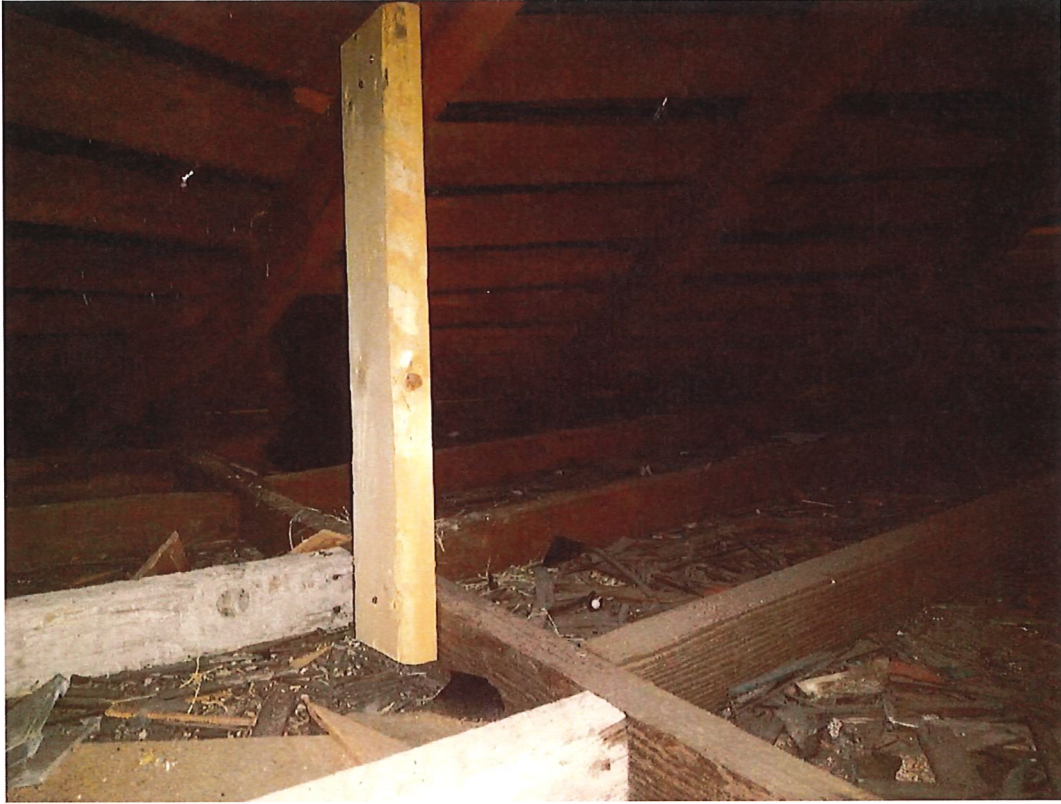
are cut at an angle and nailed to the side of the larger joists. Two approximately 2x6 posts (one of relatively newer age based on its blonde appearance) are screwed to the side of a roof joist and a ceiling joist (see photo 2, 3 and 4). Two screws are at each end. It is not apparent if either post is a brace to either of the individual joists it is attached to or an additional level of support for either the roof or ceiling as a whole. We observed that one of the roof joists is split.

- *Ceiling Structure:* Spanning between the rim joists are dimensional 2x4's to support the 3" lath with a slight rounding used for the ceiling. A central beam runs corner to corner of the octagon and supports the 2x4 joists running (generally) perpendicular between it and the rim joists. (Photos 3, 4, and 5)

- *Ceiling:* The ceiling is made of thin 3" strips of rounded wood lath. There is a significant amount of wood debris on the ceiling that appears to be from the shingles as well as some trash. (See photos 3, 4 and 5). The debris obscures much of the top of the ceiling from sight and the condition of the ceiling wood is mostly undiscernible. The visible wood is covered in dirt. From below, the ceiling is painted white and the connection method is not visible though it is likely simply nailed to the ceiling joists. (see photos 6 and 7) The ceiling has a small hatch access hole offset from the center.

Photo 4 – post in ceiling

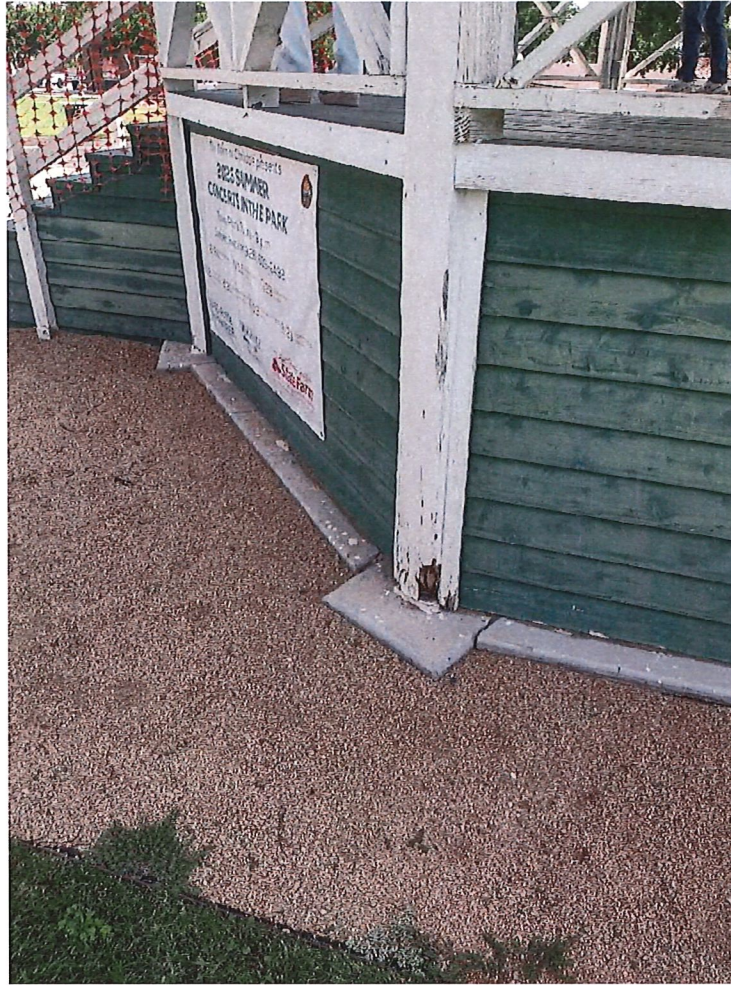
- *Columns:* The eight 6x6 wood columns are the most visible outline of the structure. Each has damage, primarily from wood rot and disintegration at the base, some more extensively than others (see photos 8). Each of the columns, whether above the floor line or below, shows some degree of being out of plumb. Heavily painted, it is not discernable by cracks or other stress indicators if the alignment is due to shifts in the structure or ground support or is from the wood drying and twisting or is the alignment of the wood when originally placed in the structure.

- *Exterior Walls/Siding:* On both sides of the staircase and below the floor around the rest of the octagon, the area under deck is walled in with lap siding appearing to be made of 1x material. It is supported with a frame of 2x4's resting on the concrete slab and nailed to the adjoining columns and floor framing. (see photo 8)
- *Concrete Support System:* A concrete slab is visible under the octagon and extending outside the octagon approximately four inches. The columns appear to rest on separately poured piers approximately 18" square. No subsurface exploration was done and no subsurface dimensions are known. The top of the slab and piers is essentially ground level. A decomposed granite ground cover provides separation between the band stand and the park lawn and on some sides there is an inch or two difference between the ground surface and the concrete surface. (see photo 8)

Photo 8 – Poor condition at base of column

- Replacement of all columns. Each has some degree of displacement in its alignment vertically. Individual replacement could be accomplished by removing and replacing the column while bracing and blocking the rest of the structure in place. The insertion of new columns would likely entail significant customization of all of the effected connections to each column.

- The structure is doomed to continue its deterioration as long as it sits on the ground and has drainage in contact with the wood. Two approaches would solve this; 1) lift the entire structure into the air and insert a footing around the entire octagon and stairway. This should be a minimum of one foot above finished grade. 2) Remove the siding and individually place 12" piers at each support (column or post) on the existing concrete. Pour stem walls under each siding wall area and reconstruct the siding to fit the new area.
- After the selected structural rehabilitation, repaint the structure and put in place a rigid inspection and maintenance schedule.

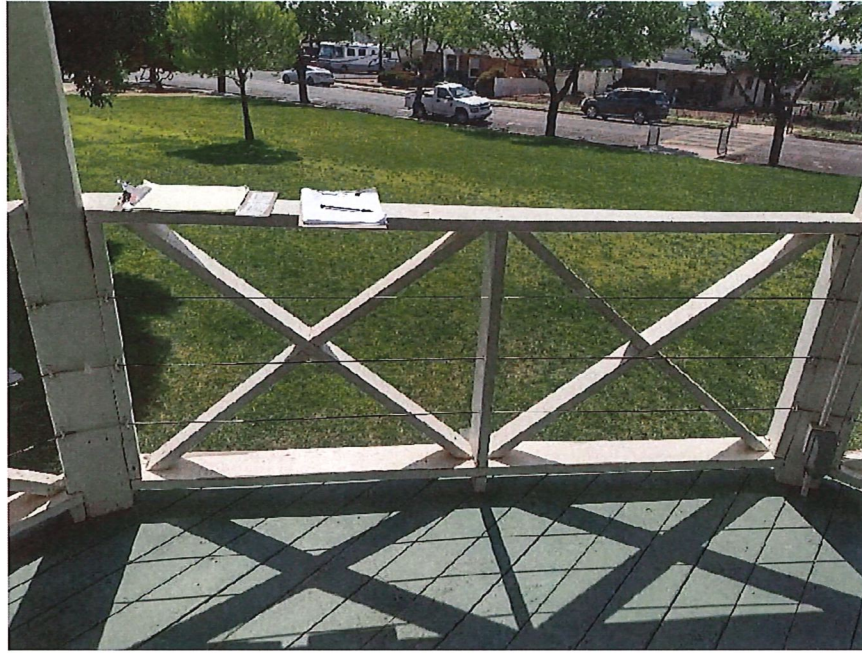
**Railings:** The railings are required to support a 500 lbs load applied laterally. The 2x6 rails bending stress for such a load is minimal, however, the shear load of 250 lbs at each end exceeds the capacity of nails whether in shear (138 lbs per nail) or pull out (40 lbs per nail) as the angle of each nail with respect to the load is uncertain and some reasonable percentage combination of the strengths would be applied as well as some amount discounted. These are considered to be unsafe.

Photo 9 – Railings

- Rebuild the railings. There are several architectural approaches to the appearance but the minimal approach would place bolts through the columns for connections at the end of the railings.
