**NOTICE OF A JOINT SPECIAL MEETING OF THE DESIGN REVIEW BOARD
AND THE HISTORIC PRESERVATION COMMISSION OF THE TOWN OF CLARKDALE
MONDAY, NOVEMBER 27, 2023, AT 6:30 PM**

Item Number: 4.A.

Agenda Item: **Joint Public Hearing of the Design Review Board and the Historic Preservation Commission: Arizona Copper Art Museum**
Joint Public hearing discussion of the Design Review Board and Historic Preservation Commission regarding APN 400-02-164 submitted by Drake Meinke on behalf of the Arizona Copper Art Museum for the removal of historic display windows and doors at the Miller building located at 901 Main Street, Clarkdale, and replaced with plywood or oriented strand board.

REGULATED BUILDING MATERIAL SURVEY
901 MAIN STREET, CLARKDALE, ARIZONA

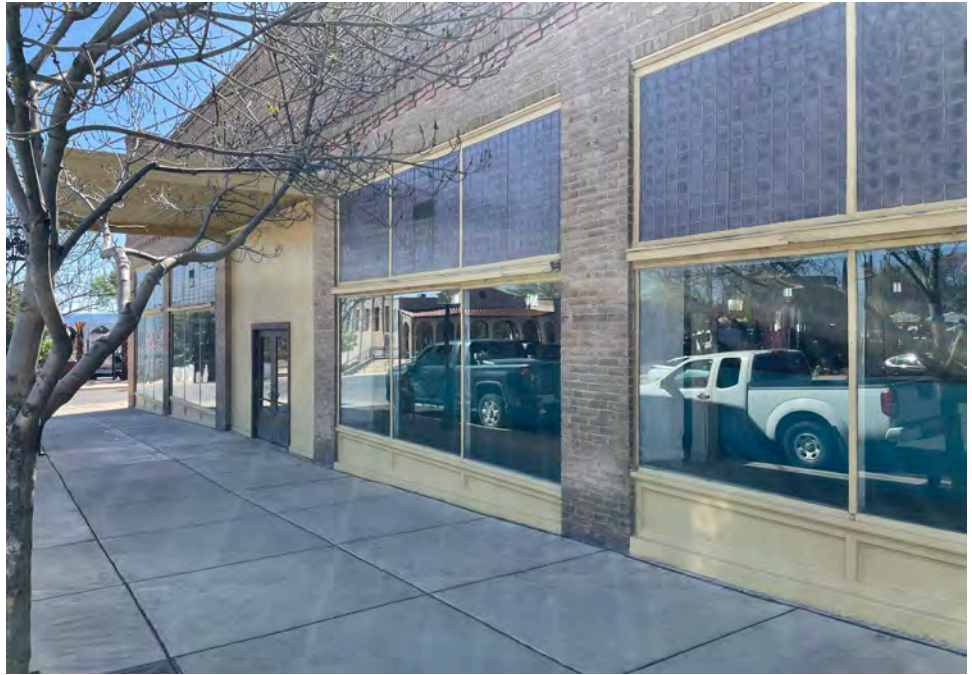
1. Exterior wood window trim and ledge
2. Exterior wood double door, single door, and trim

Photograph 1: Photo of LBP window trim, double doors, and window ledges.

If renovation is planned that would disturb the LBP components, then Ninyo & Moore recommends intact or minimal-disturbance removal of the LBP components by lead-trained workers, using appropriate work area preparation and personnel protection, prior to renovation or other disturbance of these building components. Routine demolition practices could be employed to demolish the LBP materials in place, if sufficient dust suppression and worker protection measures are included in the demolition work, and all waste materials are placed in leak-tight containers for offsite disposal.

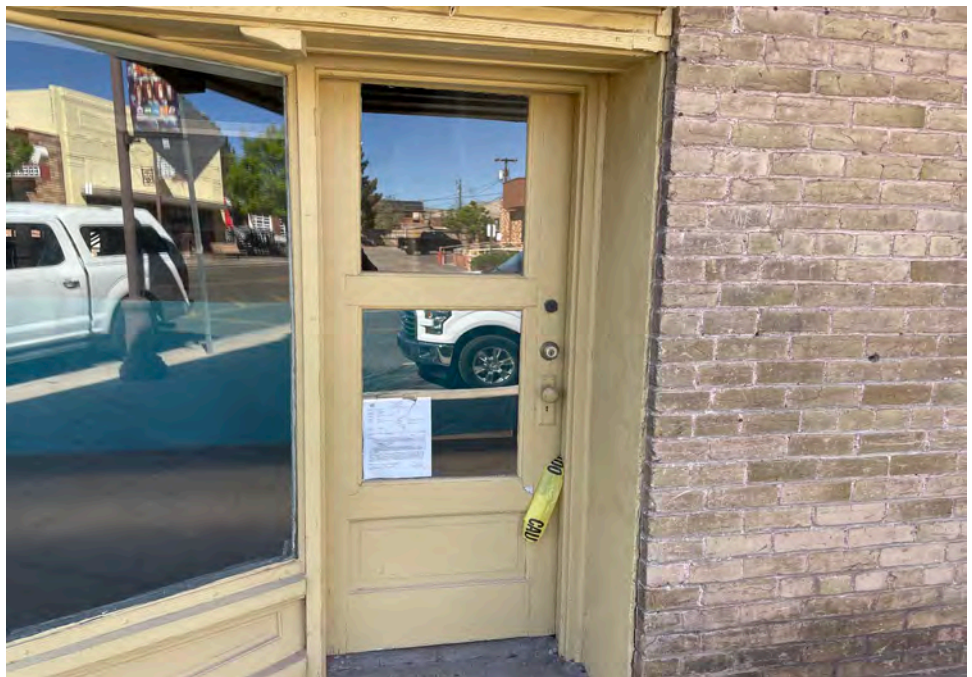
Photograph 2: Photo of LBP door and door trim.

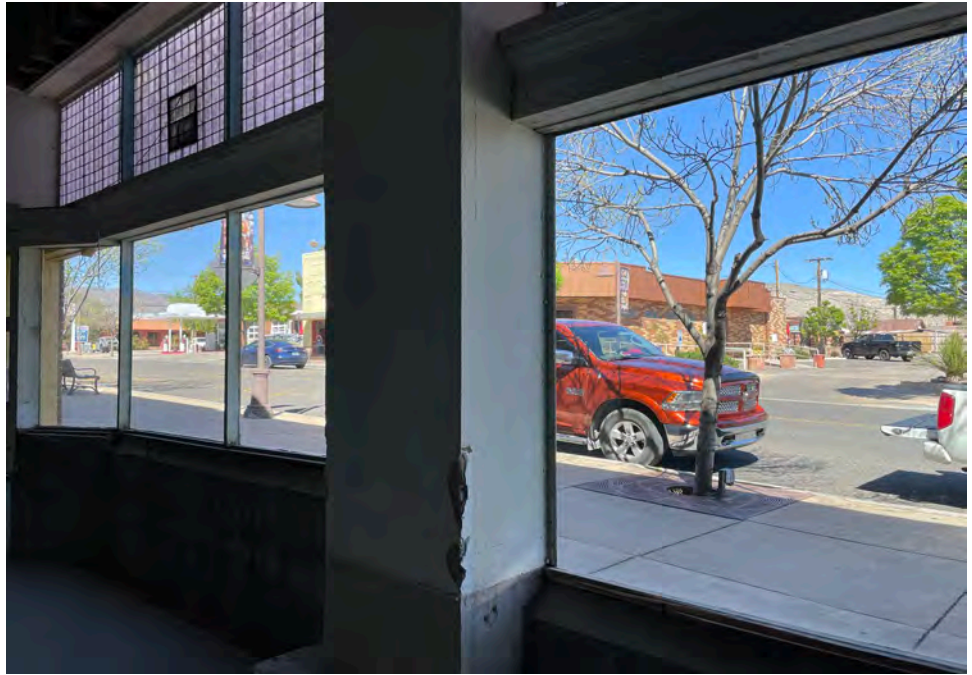
Photograph 3: Photo of LBP of A wall pillar, window frame and window ledge.

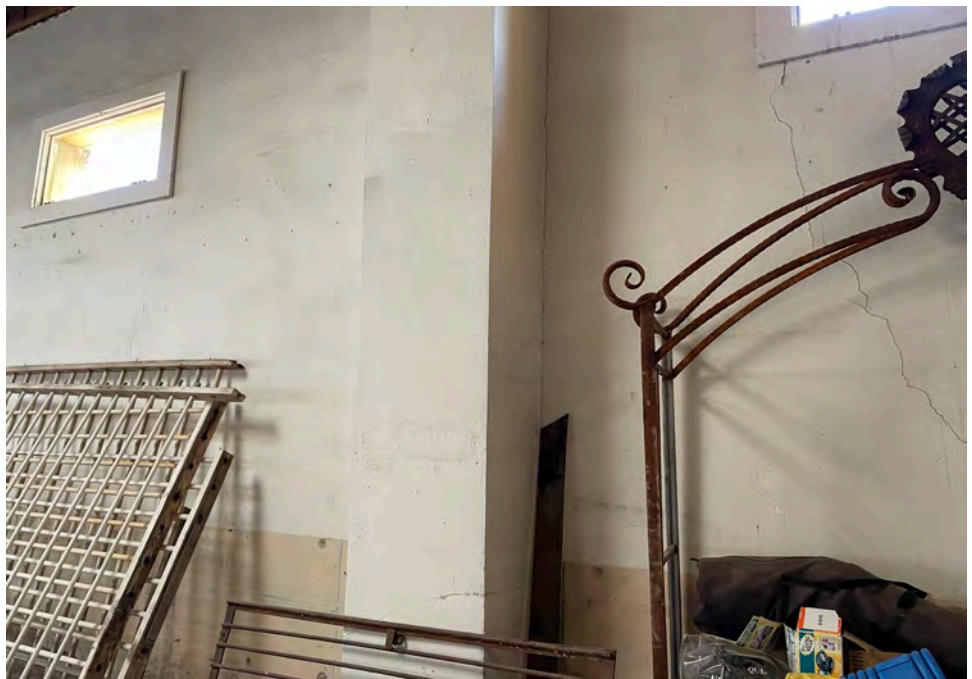
Photograph 4: Photo of LBP of B wall and window frames.

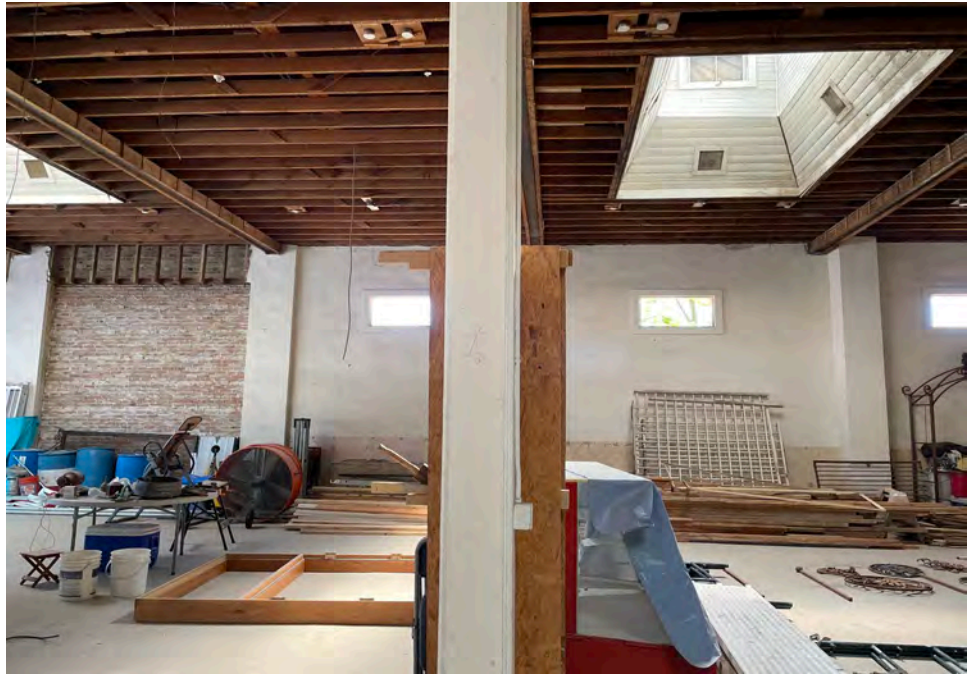
Photograph 5: Photo of LBP wood pillars.

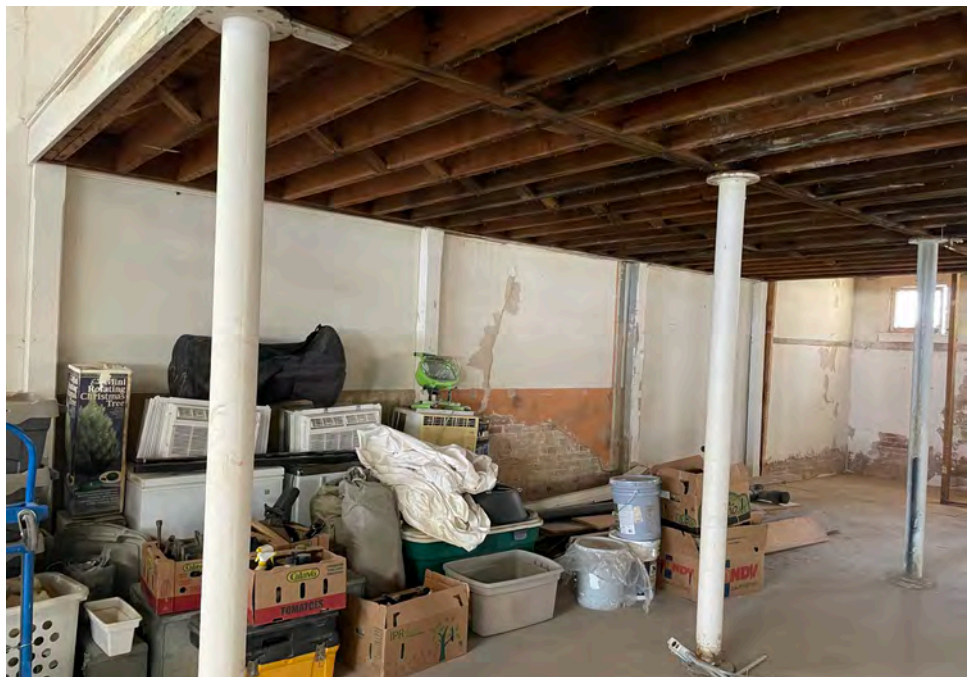
Photograph 6: Photo of LBP metal support pillars.

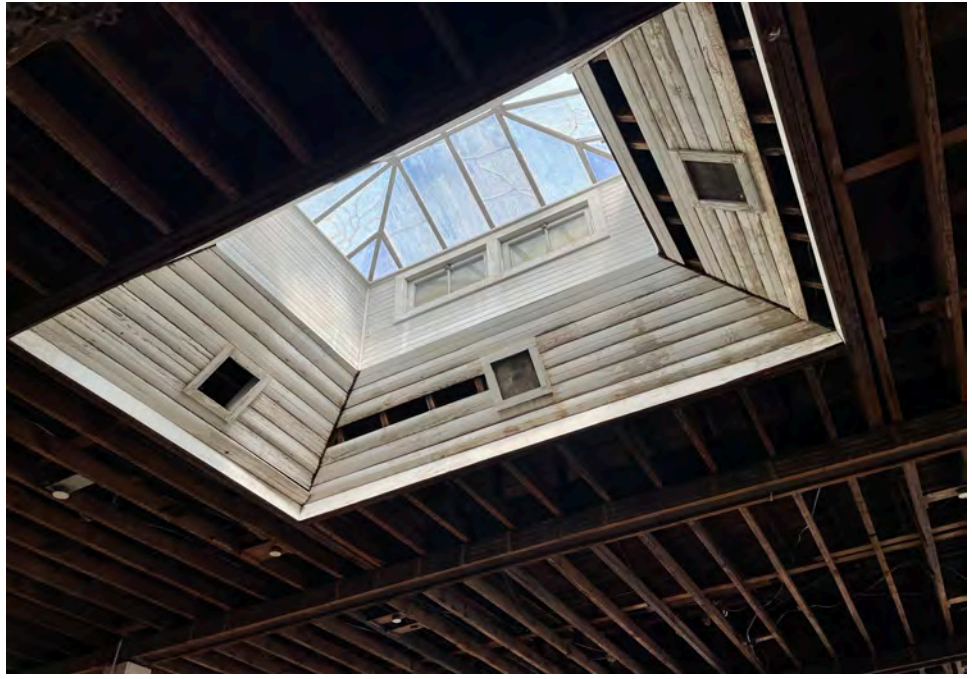
Photograph 7: Photo of LBP skylight.
