**NOTICE OF A JOINT SPECIAL MEETING OF THE DESIGN REVIEW BOARD
AND THE HISTORIC PRESERVATION COMMISSION OF THE TOWN OF CLARKDALE
MONDAY, NOVEMBER 27, 2023, AT 6:30 PM**

Item Number: 4.A.

Agenda Item: **Joint Public Hearing of the Design Review Board and the Historic Preservation Commission: Arizona Copper Art Museum**
Joint Public hearing discussion of the Design Review Board and Historic Preservation Commission regarding APN 400-02-164 submitted by Drake Meinke on behalf of the Arizona Copper Art Museum for the removal of historic display windows and doors at the Miller building located at 901 Main Street, Clarkdale, and replaced with plywood or oriented strand board.

REGULATED BUILDING MATERIAL SURVEY
901 MAIN STREET, CLARKDALE, ARIZONA

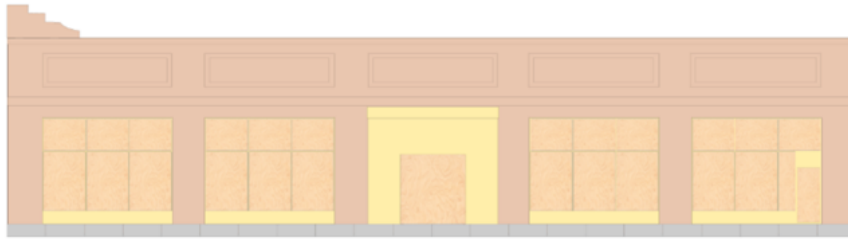
Figure 2: Main Street facade with boarding in place

In conversations with the applicant, staff have been informed that the replacement windows require a 120-day lead time, meaning that the façade will be boarded up for at least that period of time. The applicant indicated that he is unsure about the actual time that the façade will be boarded up as

the installation of replacement windows is also dependent upon grant funding. Figure 2: Boarding Plan illustrates the Main Street façade with boarding in place.

Staff cannot recommend approval of this application in its current form. Boarding up the windows and doors of this building will have a decidedly deleterious effect on the appearance of a downtown that is struggling to fill buildings.

Alternatives exist to the window and door removal and boarding up of the building for approximately six (6) months. Stabilization and encapsulation of the LBP are offered as a solution by Viking, but not discussed by the applicant. This method would not require removal of the windows or frames; specially formulated paints are used to coat the surfaces where LBP is found. In fact, the Environmental Protection Agency (EPA) provides step-by-step instructions for the use of chemical stripping agents and encapsulation paints on its website (<https://www.epa.gov/lead/lead-safe-renovations-diyers#minimize>). Using these methods, the work could be performed while the replacement windows are on order, minimizing disruption to the structure.
